Electrocution on a Press Due to Poor Grounding

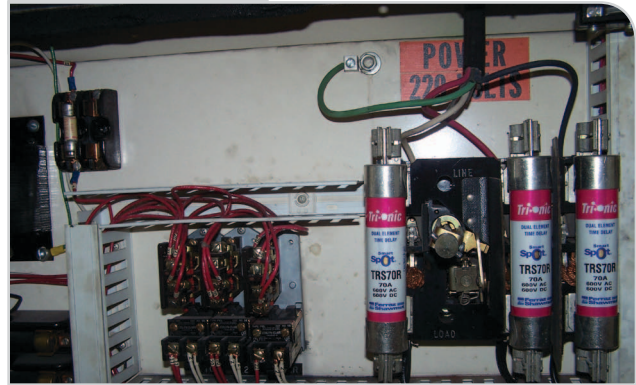
Figure 1

At the press, there was no electrical fault that was concerned with the press itself. The 240-volt, three-phase grounded delta feed to it was reported to have been shut off when the accident occurred. With power off to the press, no voltage to ground was found anywhere on the press. Also, the resistance to ground (the building steel) from the press was measured to be 0.075 ohms.

The grounding of the press was through the green wire of a four-wire flex cable that fed into the contactor box located

on top of the press (Figure 1). This ground wire was there at the time of the accident. After the accident, a maintenance technician had installed a ground to the inside of the disconnect switch that fed this control box on the press. Both of these ground wires were grounded from being bolted to the inside of the junction box in the truss area where the flex cable is connected to feed the press. Thus, they are tied electrically to the building steel, as was one leg of the 240-volt delta transformer secondary (noted above).

Grounding of the press.

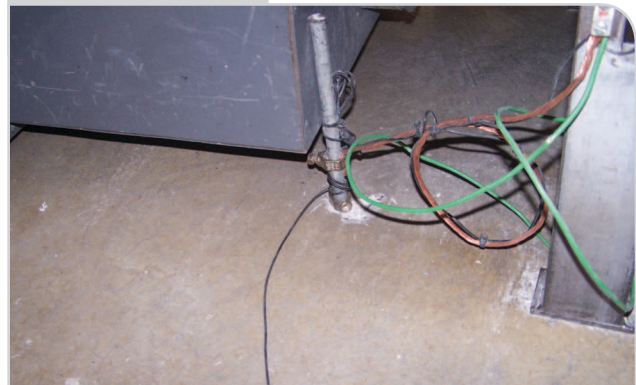
Figure 2

Prior to the accident, the conveyor was grounded by being connected to a driven "ground rod" located at the exit end of the conveyor. After the accident, the facility's maintenance technician had run a bare stranded wire from the ground rod of the conveyor (and thus the grounding system for the conveyor) to the base of the press. This gave the conveyor an adequate ground through the press to the building steel (Figure 2). Measurements taken during the investigation with this added ground wire disconnected showed that the "ground rod" had a resistance of about 90 ohms to the building steel framework. Note that if the conveyor had been energized at 120 volts, with

a ground as poor as that which is noted, the current drain would have been small. Using $I = V/R$, at 90 ohms ground resistance, the current would have been about 1.33 amps. This would not trip a 15-amp circuit breaker, thus the conveyor frame would not have been de-energized automatically, and at the time of the accident, the conveyor had not been effectively grounded. (With the added bare wire connected, that was installed after the accident, the resistance to ground from the conveyor was 0.075 ohms.)

At the time of the accident, the press was solidly and effectively grounded and the exit conveyor was not, since it was connected to a ground rod that had high resistance to the building and thus to the electrical system ground. Note that section 250.110 of the National Electrical Code requires that the non-current-carrying parts of equipment be grounded. Further, the definition of “effective grounding” requires that the resistance of the grounding system be low enough to prevent elevated voltages on the equipment framework. Thus, the low value of resultant ground current noted earlier would not have prevented elevated voltages on the conveyor framework.

The major contributor to the accident was the improper grounding of the conveyor frame. Had it been properly grounded, then whatever caused the frame to be energized would have caused a high-current short, which would have tripped the supply circuit protective device, thus removing the dangerous condition.

Grounding of the conveyor.

Using a driven ground rod instead of connecting the conveyor to the building framework, either directly or by interconnecting to other pieces of the machinery, was the basic mistake made. All grounding systems must be effectively bonded together in order to achieve the electrical safety that all codes require. ♦
