Hand Amputation in a Molten Metal Furnace

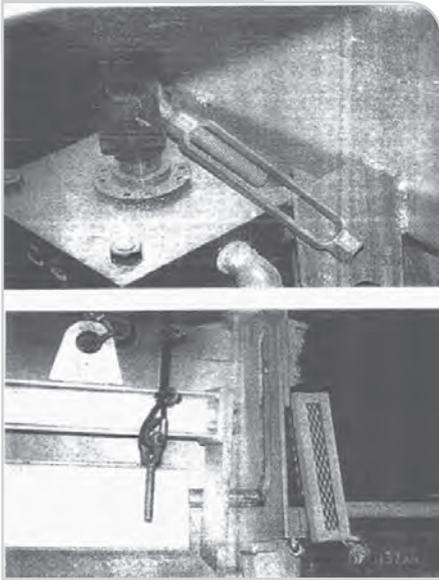
Figure 1

A particular factory production process required molten metal samples to be taken from the furnace for testing every two hours by employees. This was an aluminum holding furnace, operating at about 1,400°F. One employee lost a hand when the open furnace door through which he was sampling fell on his arm. The door fell because a turnbuckle was rotated in such a fashion as to unscrew one end and thus released the door.

Any non-locked turnbuckle, if acted upon so as to turn one of its eyebolts repeatedly in the same direction while holding the other stationary, will eventually cause one end to turn such that it screws into the center body to the end of its threads, and it unscrews the other end completely out of the center body, as shown in Figure 1.

Photos of the failed turnbuckle.

- Normal maintenance could have and should have revealed, during preventive maintenance operations, that the turnbuckle was slowly becoming unscrewed. This should have been acknowledged and the cause found and corrected. ♦

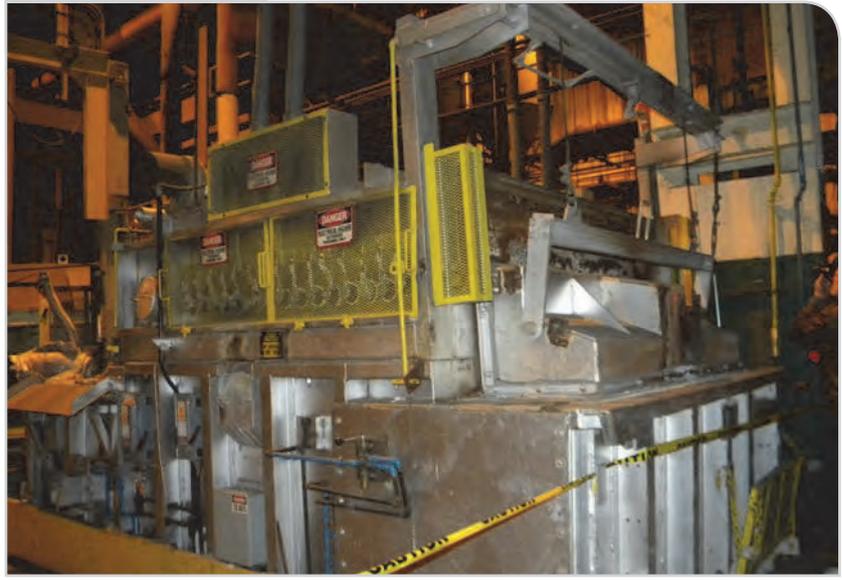
Figure 2

Rebuilt furnace and footed door.

The new design had a total of 15 electrical “glo-rod” heating elements, as opposed to the nine in the original design. To accommodate the additional heating elements, the upper section of the new design was longer than that of the original one. The top section extended almost to the end of the lower shell. There was no room for the clamshell or similar sampling doors (see Figure 2).

2. There were two distinct failures made by the plant personnel:
 - The operating practice of sampling through the door without engaging the safety gravity hook allowed the door to fall when the turnbuckle let loose. This hook assembly can be seen in the upper part of Figure 2. This is a definite breach of conduct for lockout/tagout procedures as required by U.S. Occupational Safety and Health Administration rule 29CFR1910.147, in that the potential energy of the hoisted door must be controlled. Proper employee education and operational monitoring would have prevented this occurrence.

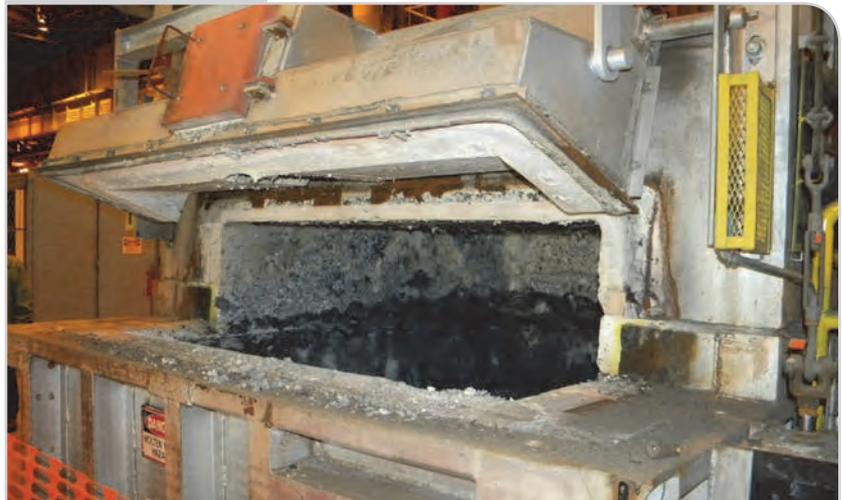
The new furnace was designed with a single “footed” door, which was placed at the end of the furnace. It replaced the original vertical lift door and the two clamshell doors. This door had both a vertical section and a horizontal section and weighed approximately 1,650 pounds (Figure 3).

The new footed door reused the same gravity hook and lockout system that was present on the main furnace door of the original furnace. This door was operated by a pneumatic cylinder through a hand air valve. The cylinder rod was connected to the door by means of a double cable arrangement — as can be seen in the right side of Figure 3 — that fed up over a double-grooved pulley to the lifting beam for the footed door. This cylinder was not of a “non-rotating” design, such that the internal piston and external operating rod could rotate about their axis (see Figures 3 and 4).

New footed door and view of cylinder and turnbuckle to the right.

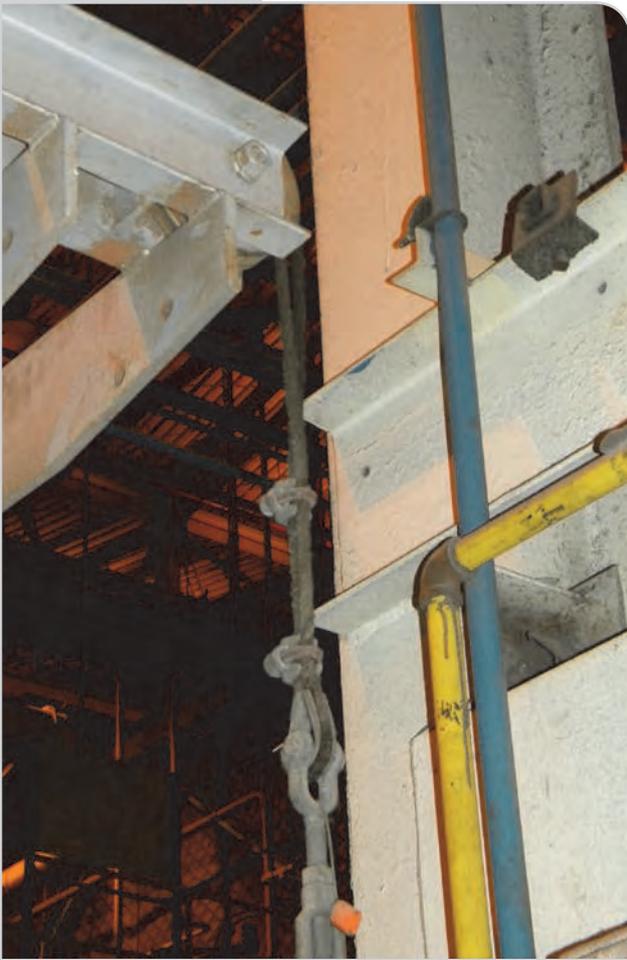
Figure 4

Note, from the twisted cables in Figure 4, that this cylinder has, during operation, rotated in a counter-clockwise direction, when viewed from above. This photo was taken after the accident, and there now has been a set of locking devices installed on the turnbuckle. When the accident occurred, there were no locknuts, cotter pins, sealing wire or any other means installed to prevent either turnbuckle end’s eyebolt from screwing into or out of the turnbuckle’s center body.

Twisted cables.
