Report on the NSSMC Oita Works' Fire Accident in its Plate Mill - The cause and preventive measures -

May 18, 2017

Nippon Steel & Sumitomo Metal Corporation

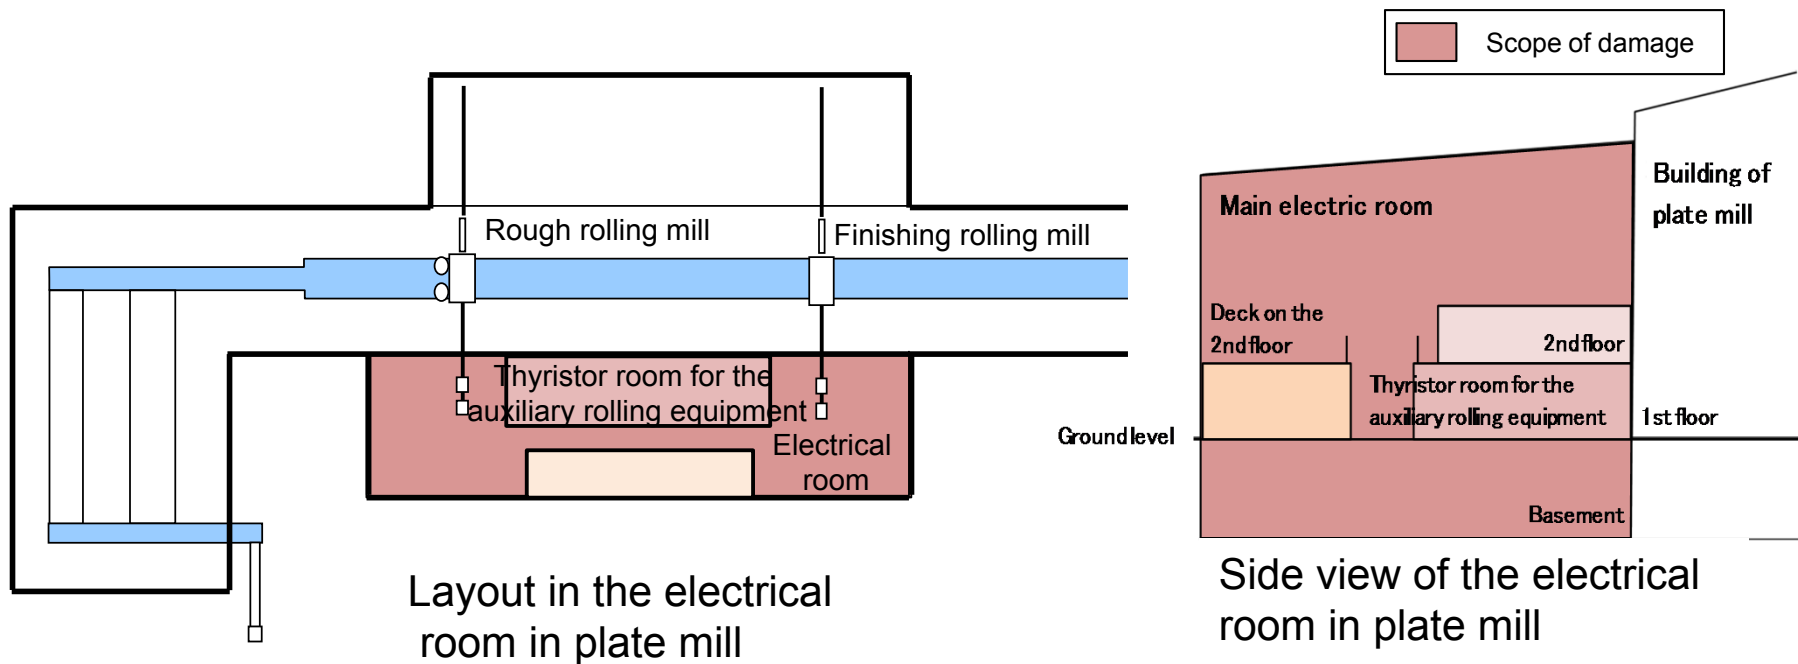
Scope of Damage

- Almost all control panels and cables in the electrical room burned.
- The building of the electrical room was damaged, and part of its floor-supporting steel frames were damaged.
 - The rolling line of the plate mill became inoperable.

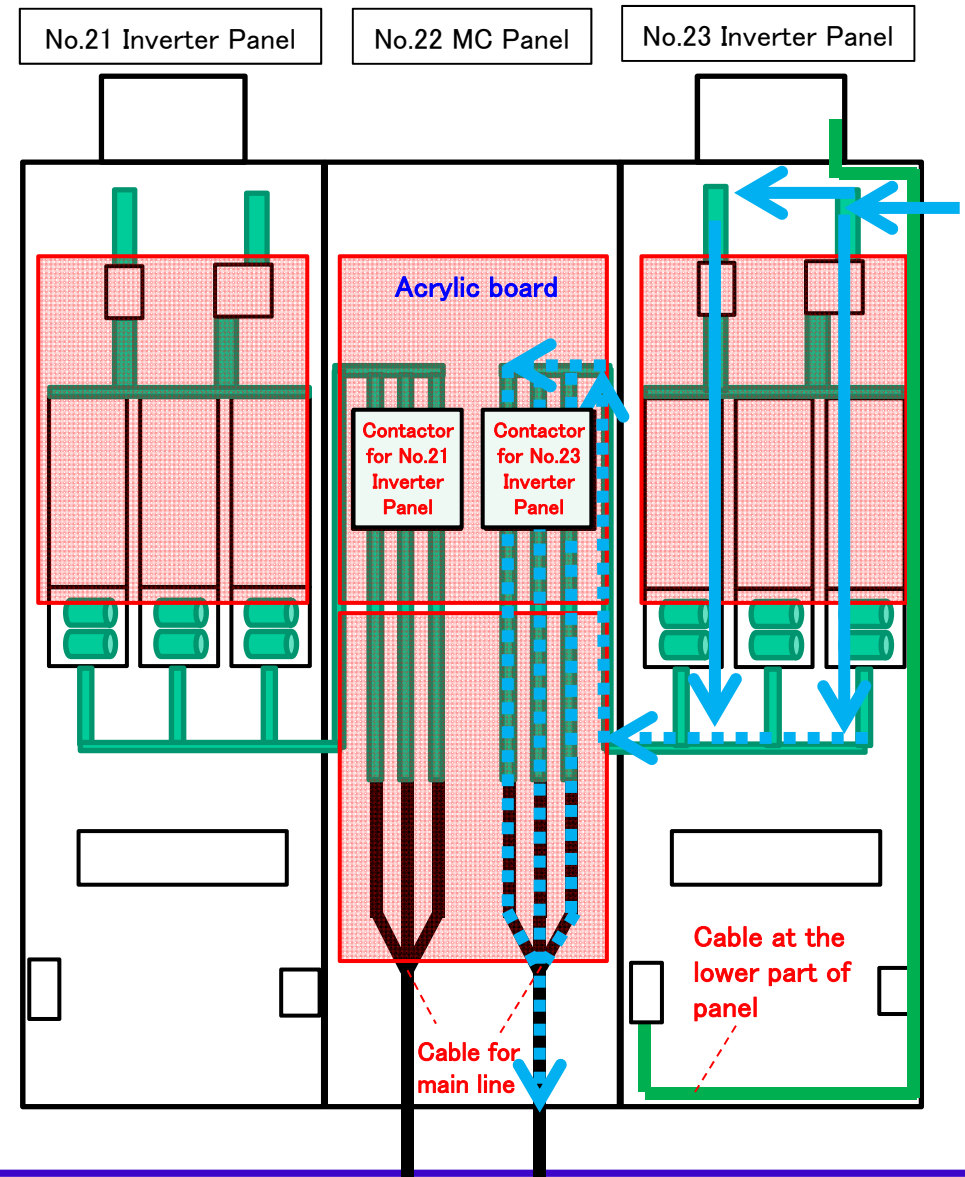
- Presumed origin of the fire:
MC panel for auxiliary rolling equipment (entered operation in 2009)
- This electric panel supplies and controls power (electricity) to a roller that feeds materials to a rolling machine.

MC : Magnetic Contactor

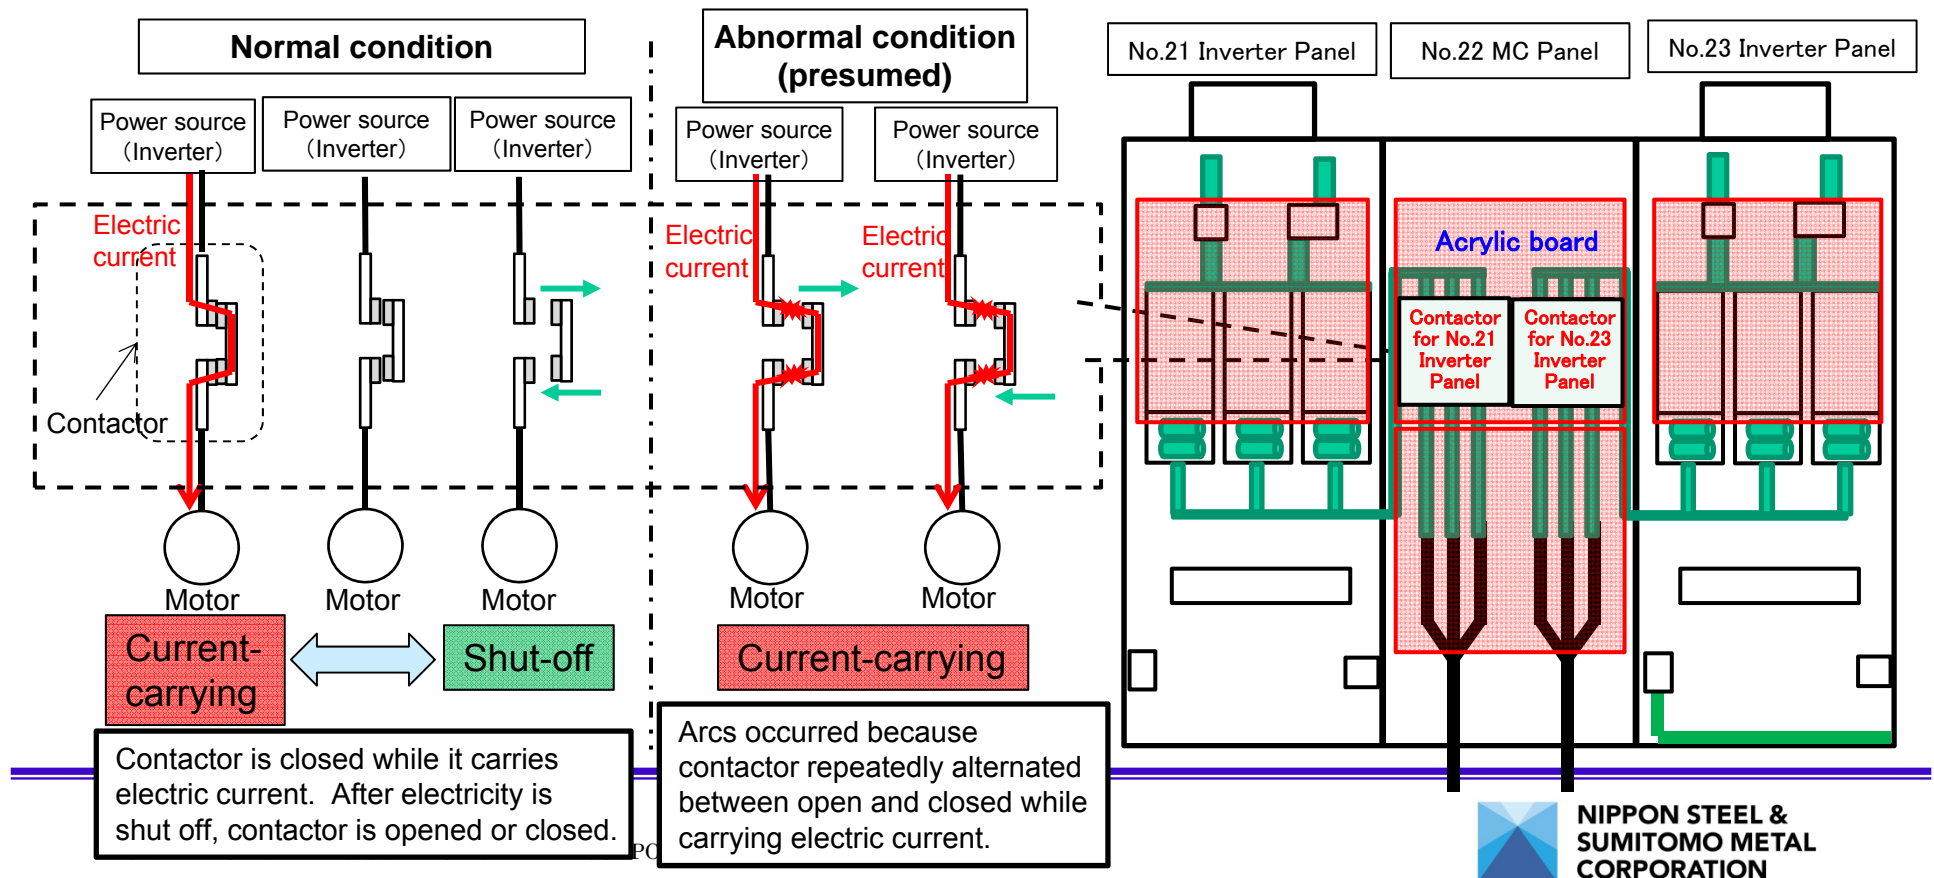
- Presumed cause of ignition

A control panel that orders a contactor inside the MC panel to open or close output abnormal control signal, and the contactor repeatedly alternated between open and closed while carrying electric current. As a result, arcs occurred continuously from the contactor and ignited flammable components of the panel (acrylic board for prevention of electric shocks, etc).

- Installation of circuits that shut off electric current in case of the occurrence of abnormal control signal

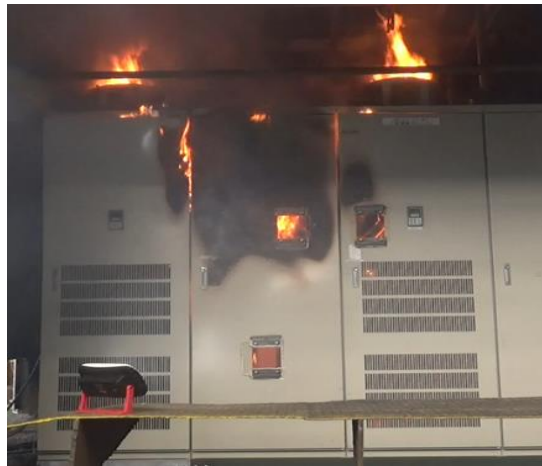
At the start of the experiment

We reproduced the circumstances, which did result in the occurrence of arcs from the contactor and the ignition of flammable components of the panel (acrylic board, etc.)

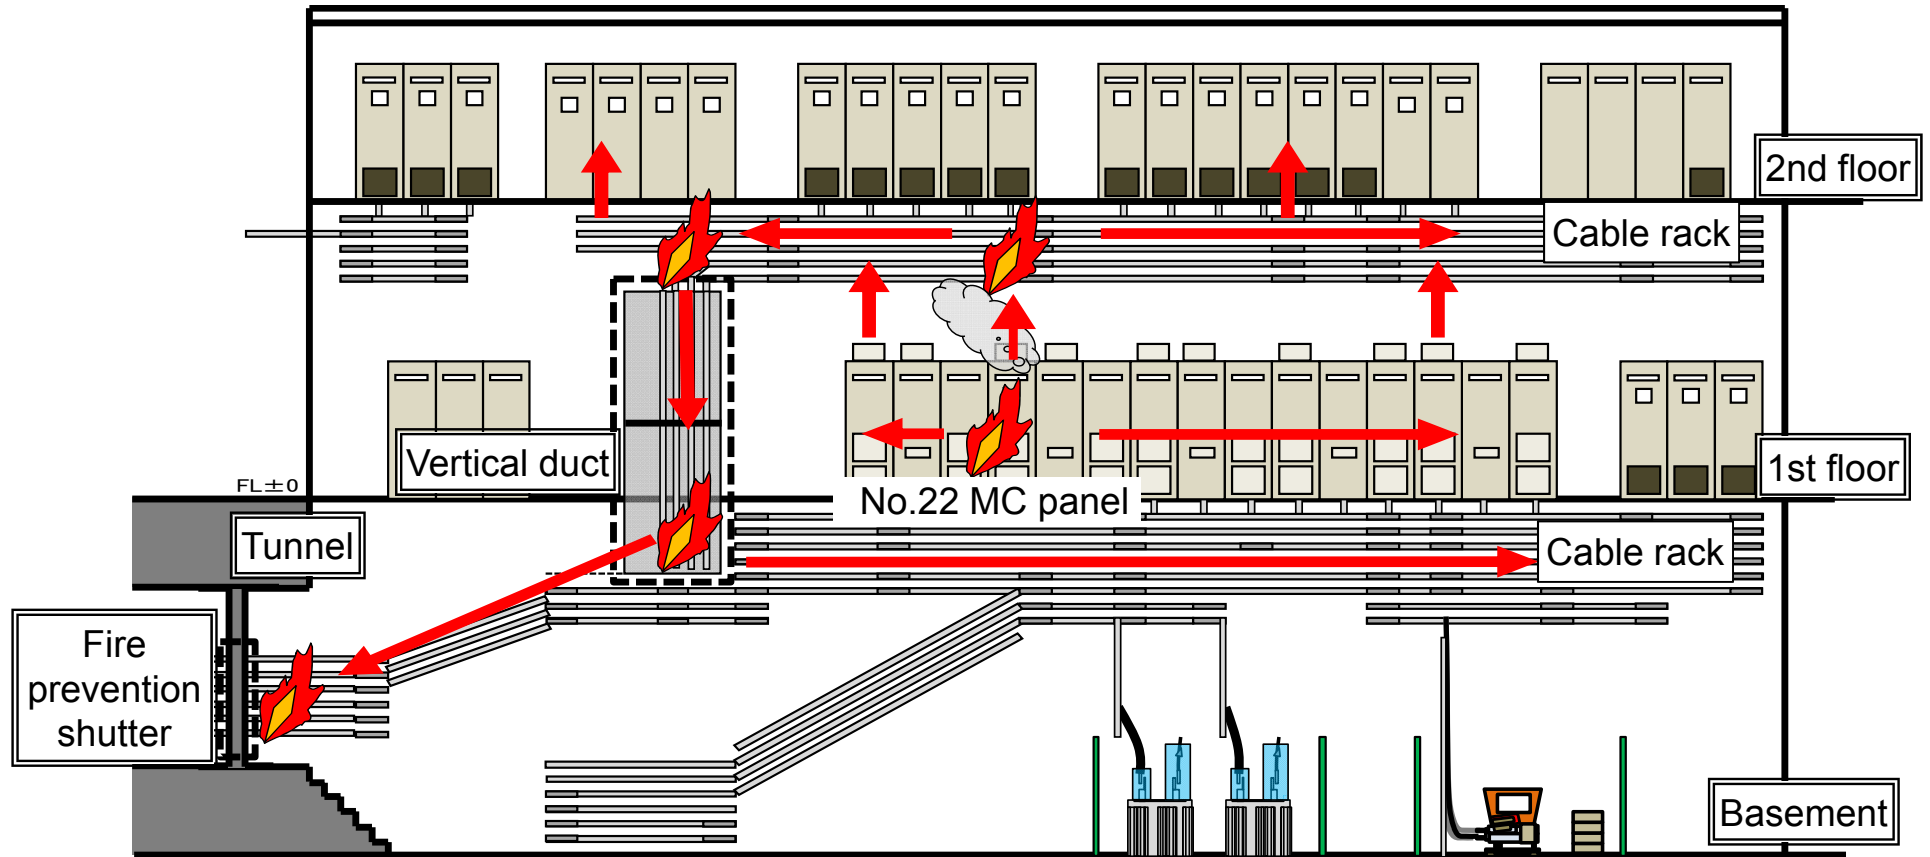
- Presumed cause of the spread of fire

Flames spread to adjacent panels and cables, and then spread across the entire electrical room from the 1st floor to the 2nd floor, and then to the basement.
