# Reduction of Surface Defects on Steel Pieces That Occur in the Early Stages of Casting

While scabs and longitudinal surface cracks of rolled products can occur during the rolling process, there are cases where surface cracks on billets do not disappear during the rolling process and remain. This article introduces efforts against the following surface cracks that appear during the continuous casting process, which occur at the initial casting stage at the bottom of oscillation valleys: (1) Short-stroke/high-cycle mold oscillation; (2) Optimization of mold dimple patterns; and (3) Improving responsiveness of mold level control.

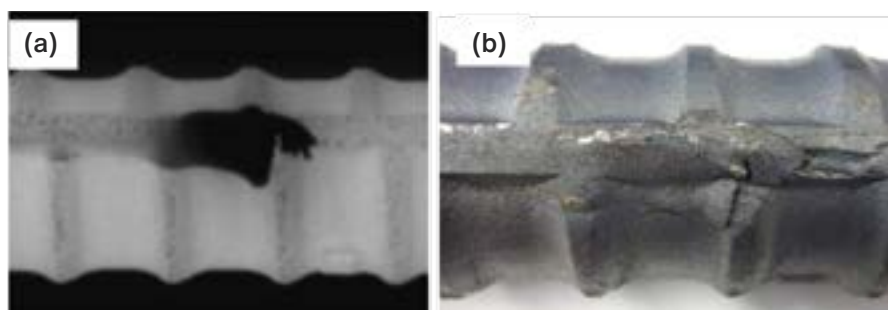
Figure 1

Comparison of product defect detection images (a) and actual defects (b).

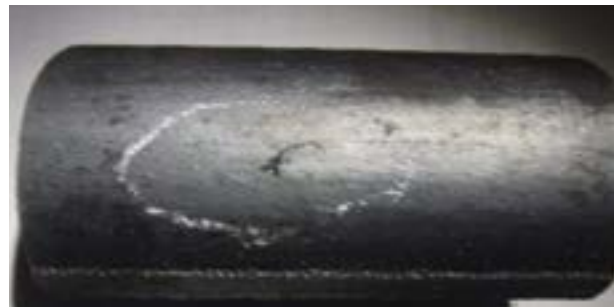
Figure 2

Approximately 99% of the defects found by product defect detection equipment were defects that looked like the surface of a deformed steel bar was beginning to peel off. In order to identify the location and timing of the occurrence of surface peeling defects, crop material was investigated in the rolling process and signs of peeling defects were found (Fig. 2). Furthermore, the location of the peeling defects was equivalent to the corners of the billet. Additionally, when the steel billet was inspected at the early stage of rolling, signs of peeling defects were already present. This led to the conclusion that the cause of the peeling defects was defects on the surface of the steel billet.

Signs of peeling in the middle of rolling.

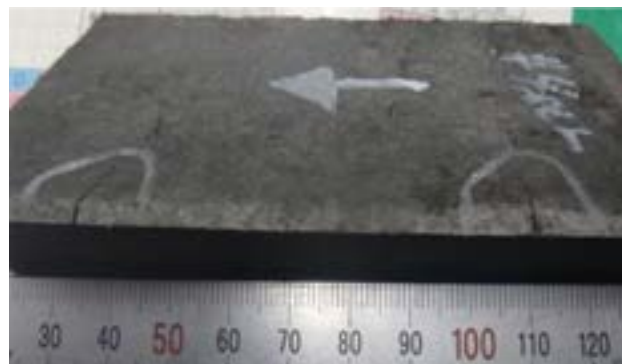
Figure 3

A detailed observation of the billet with a large number of peeling defects revealed that transverse corner cracks had occurred at the billet corners, shaped along the

Billet corner crack.

grooves of the oscillation marks (Fig. 3 and 4). When this billet was rolled, peeling defects occurred in the rolled deformed steel bar at the positions corresponding to the corner cracks of the billet.

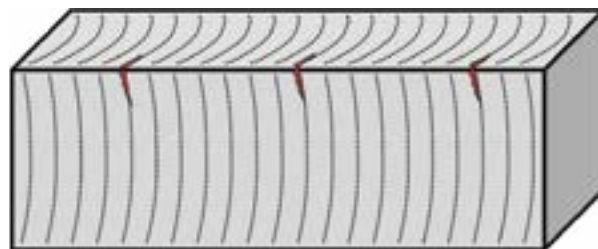
Figure 4

Image of transverse crack at billet corner.

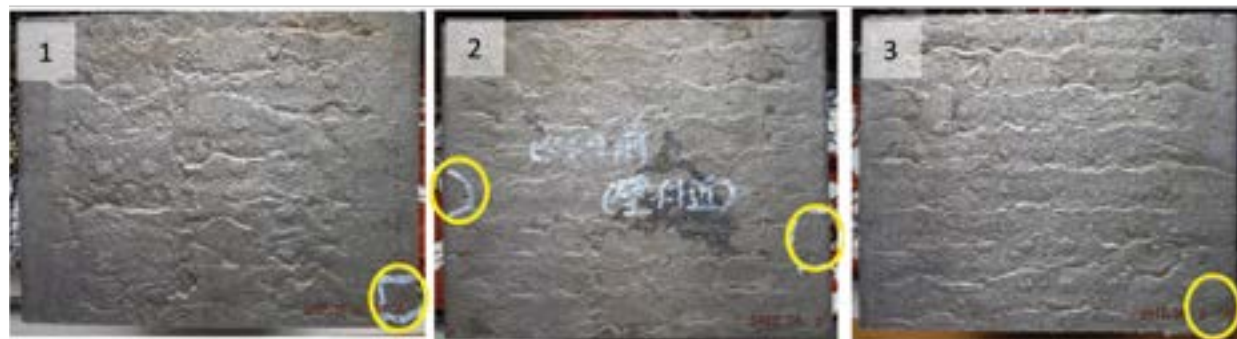
Figure 6

through the pinch rolls. The spray flowrate and cooling position in the secondary cooling zone of the billet were adjusted, but the occurrence rate of peeling defects in deformed steel bars did not decrease. In order to confirm the occurrence location of transverse corner cracks, the billet was stopped during casting in the spray cooling zone before passing through the pinch rolls and samples were taken at the positions shown in Fig. 5. As a result, it was found that the cause of the transverse corner cracks had already occurred before the billet was straightened by the pinch rolls.

Transverse section sample (crack in yellow circle).

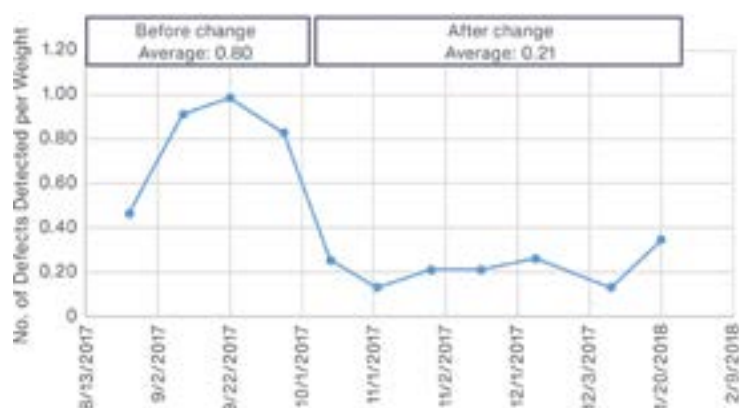
Figure 7

Changes in defect occurrence rate due to changes in mold vibration settings.

By changing the vibration settings, the depth of the oscillation marks became 30% shallower. In addition, after changing the vibration settings, the defect occurrence rate of surface peeling defects for the main sizes of deformed steel bars decreased by approximately 0.6 case/rolling ton.

Based on this, the mold vibration conditions were changed as shown in Table 2. According to Kajitani

et al.,<sup>3</sup> short tN can cause restrictive B.O., and a criterion is to maintain tN of 0.1 second or more, so it was set so that tN would be 0.1 second or more, taking into account fluctuations in the pouring speed.

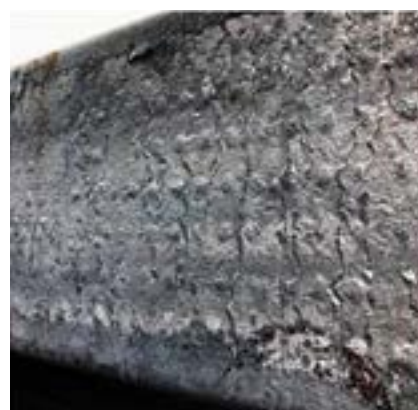
Figure 8

When a large amount of peeling defects occurred in deformed steel bars during hot direct rolling, the marks of the dimples on the inner surface of the mold were clearly visible on the billet surface. Therefore, the relationship between dimple marks and billet corner cracks was considered.

Cast piece with dimple marks remaining on the surface.

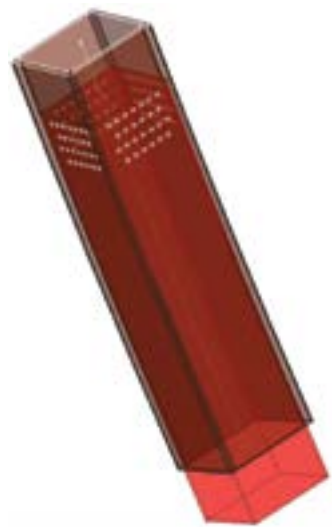
Figure 9

At the factory, a dimple mold is used to prevent the billet from deforming and causing internal cracks. On the inner surface of this mold, multiple dimples are machined below the meniscus (Fig. 9).

Dimple mold image.

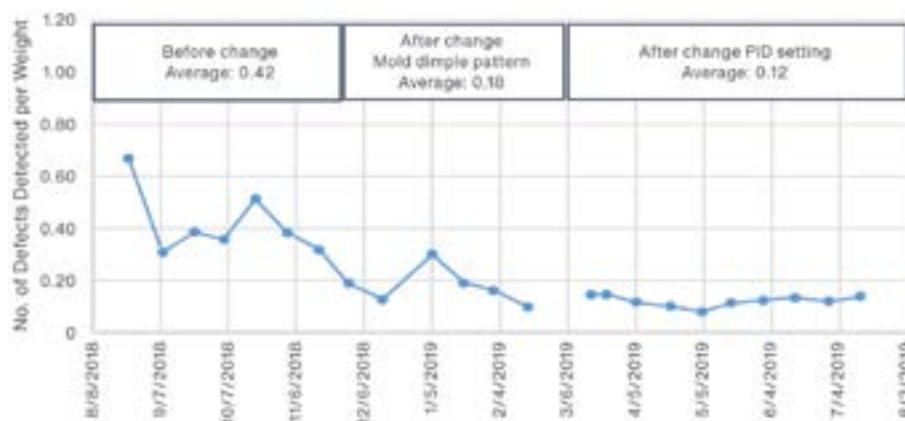
Figure 11

By increasing the control coefficient, the fluctuation in the casting speed became larger, but the fluctuation in the mold level was suppressed, and no problems occurred with casting. After that, operations were carried out using the settings in the second test stage in the table. By implementing change in mold dimple pattern and improving responsiveness of mold level control, the incidence rate of peeling defects decreased by approximately 0.3 cases/t of rolling (Fig. 11).

Changes in the number of defects detected during rolling of major size deformed steel bars.

As a countermeasure, the PID setting value was gradually adjusted and the control coefficient was increased so that the meniscus would return to the set mold level in the shortest possible time.
