Investigation on Caster Breakout During Flying Tundish Change and Separator Plate Using Innovative Techniques at ArcelorMittal Dofasco's No. 1 Continuous Caster

A caster breakout event occurred at ArcelorMittal Dofasco's No. 1 Continuous Caster in proximity to a grade transition with a flying tundish change and separator plate. Practices of flying tundish changes and separator plates have been well-established to cast grades of different chemistries with minimal interruption to productivity. Hence, it was unusual that a breakout occurred, well below the mold, despite these practices and this specific grade transition being successful multiple times prior. This article discusses innovative tools and techniques for the extensive investigation carried out and proposes an explanation of the breakout event, supported through evidence in the autopsy.

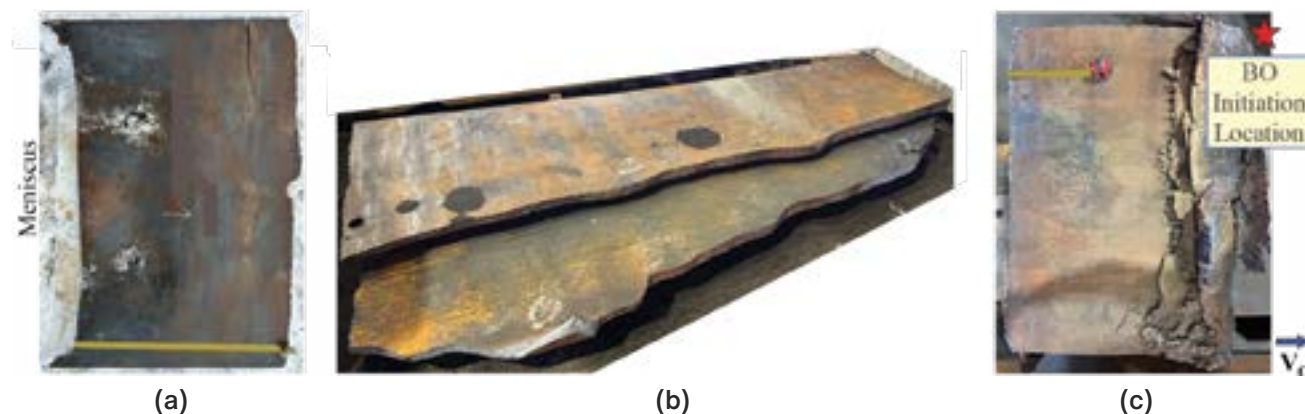
Figure 2

Breakout shell extracted from 1CC at mold (a); Segment 0 – Bender (Note: Photo is of a portion of the shell after it fractured) (b); and upper section of Segment 1 (c).

The breakout occurred on Strand 1 of ICC's 2-strand caster. The breakout initiation location was located near ICC's Segment 1 exit, ~6 m below the meniscus. As a result, there was a very extensive breakout shell (Fig. 2).

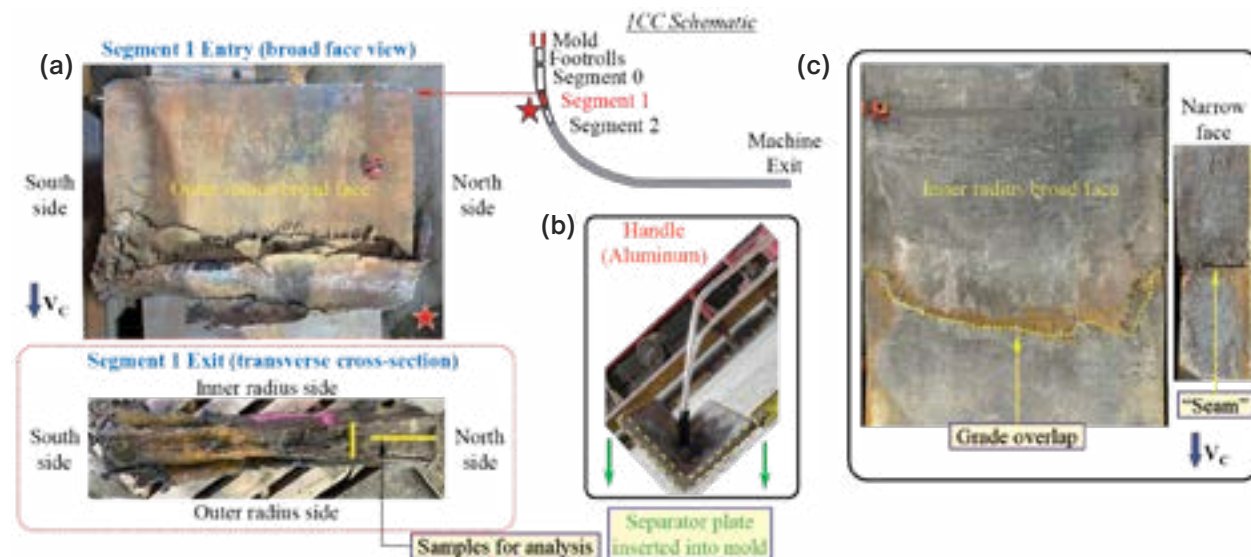
Figure 3

Further inspection of the breakout shell from Segment 1 revealed the steel strand had completely separated into two pieces along the strand width (Fig. 3a). This location was believed to be where the grade separator plates had been inserted. Fig. 3b shows an example of a separator plate used at ICC. Initially, it had not been determined how the TC-SP contributed to the breakout event since

There are two distinctive features on the successful TC-SP slab to note (Fig. 3c). First, there is a U-shaped grade overlap on the broad face where the incoming grade of steel overflowed onto the outgoing grade of steel in the mold. Second, there is no such overlap on the narrow face, but rather a "seam" showing the process interruption of the casting process and separation of the two steel grades.

Breakout shell extracted from Segment 1 of 1CC (a); example of grade separator plate inserted into mold during TC-SP (b); and slab from successful TC-SP (i.e., no breakout) for baseline comparison (c).

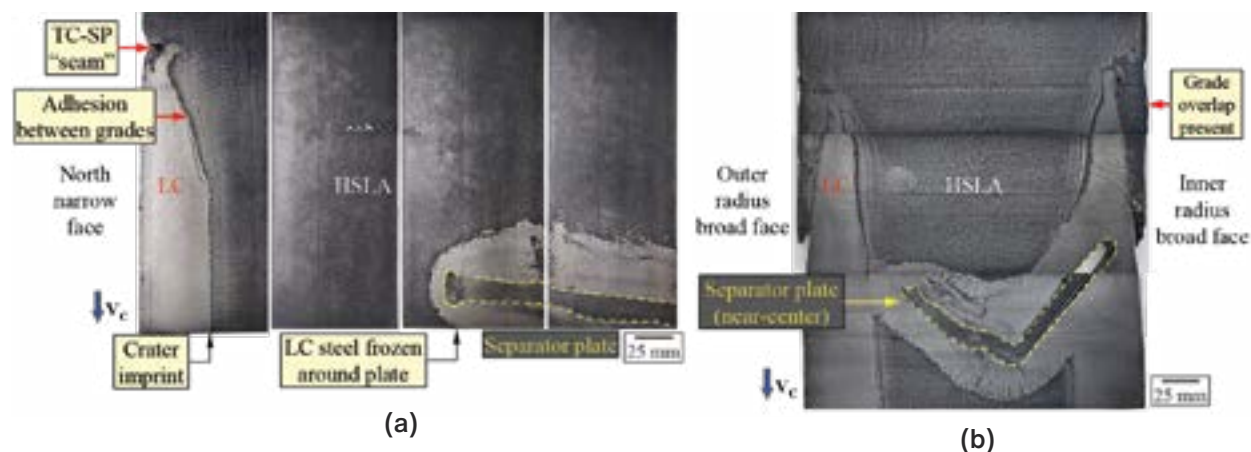
Figure 4

and HSLA (dark areas) and the crater shape at the time of the TC-SP. The separator plates are clearly visible in both cross-sections. In addition, steel of the outgoing grade (LC) had solidified around the separator plates prior to steel of the incoming grade (HSLA) being poured and mixing. Lastly, the grade overlap observed on the broad faces of the slab is visible in Fig. 4b as well as the “seam” on the narrow face in Fig. 4a. Along the seam and the grade overlap, there is good adhesion between the incoming and outgoing steel grades.

Deep-etched macrostructures of baseline TC-SP slab sample at broad face cross-section (a) and longitudinal cross-section (b) at mold quarter-width position.

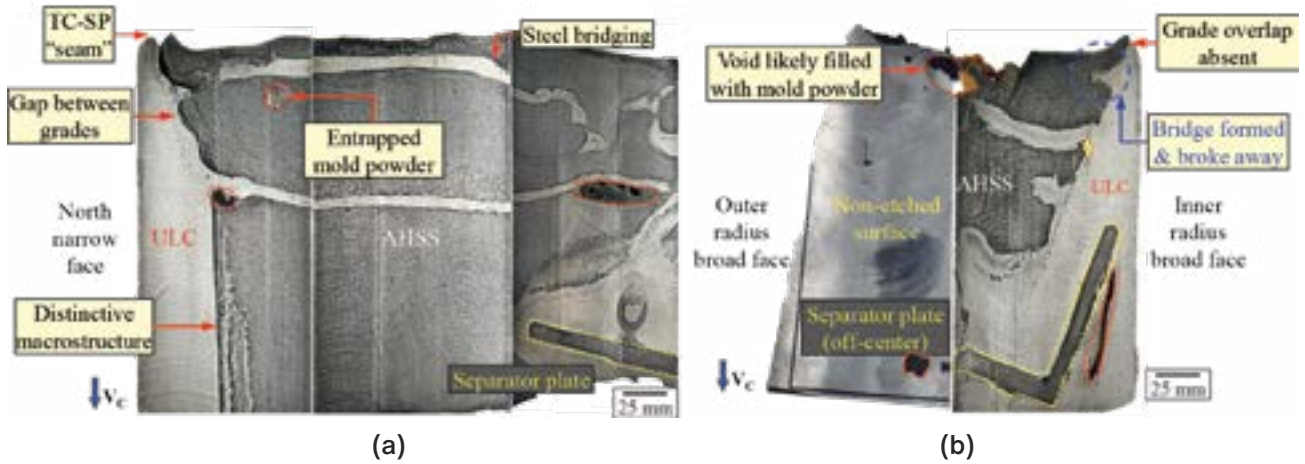
Figure 5

1. Cross-sections of the grade separator plates are present as well as solidification barriers of ULC that had formed around them. However, the separator plate is off-center and toward the inner radius broad face surface (Fig. 5b).

Deep-etched macrostructures of breakout slab removed at broad face cross-section near north narrow face of breakout slab at Segment 1 exit (a) and longitudinal cross-section at mold quarter-width location (b).

- Grade overlap, observed on the broad face surfaces of the baseline TC-SP slab, is notably absent. Furthermore, the presence of the TC-SP seam near the north narrow face (Fig. 5a) indicates the breakout originated near the TC-SP event.

- Solidification bridges of ULC, transversing slab surfaces, are present. There are also instances of broken or short solidification bridges. It is suspected that there were bridges that had formed but broke off and washed away when new steel was poured into the mold. This is further supported by breaks in the solidification bridges observed in Fig. 5a.

- Entrained nonmetallic globules are present near the bridges and separator plates — later confirmed to be mold powder. Also, voids are also present in the steel, but it was likely that similar mold powder globules were present in those voids and fell out during sample preparation.

- A distinctive macrostructure along the crater wall near the narrow face surface (Fig. 5a).
- Separation of steel or gaps along the crater wall near the TC-SP seam between the incoming and outgoing grades.

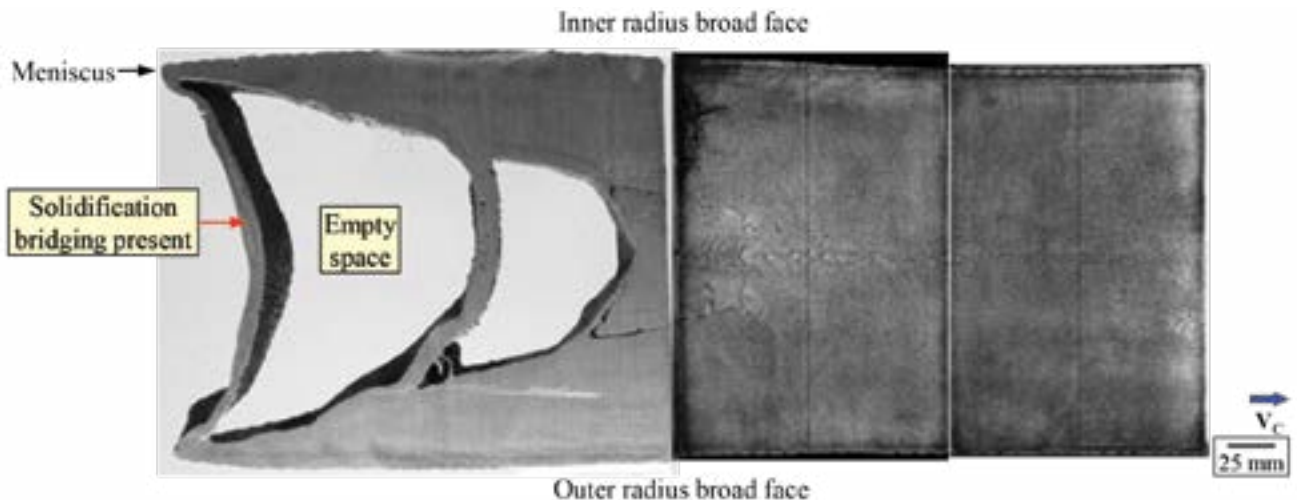
Figure 6

Deep-etched cross-section of tail-out slab sample with examples of solidification bridging. Steel shrinkage and lack of incoming steel resulted in empty space between bridges.

The solidification bridging phenomena had been documented once before at ArcelorMittal Dofasco during another investigation pertaining to a sequence break event and a tail-out slab. In Fig. 6, the longitudinal cross-section of the tail-out slab shows multiple layers of solidification bridges starting at the meniscus. Empty space was found to be between those bridges. During a sequence break, heat retention is reduced, owing to the absence of sufficient mold powder to provide insulation over the liquid steel. As a result, the steel at mold level is solidified. However, steel shrinkage caused by solidification along the steel strand still occurs and liquid steel is still being drawn into the crater. With no incoming liquid steel to replenish the crater, an empty space is left under the solidification bridge. This phenomenon occurred several times, creating multiple solidification bridges. The same phenomena can explain the presence of solidification bridges in the breakout slab. A long duration without new incoming liquid steel and lack of mold powder additions resulted in too much heat loss and solidification of the liquid steel surface in the mold. However, when new liquid steel was finally poured into the mold, it was able to penetrate through the bridges and fill what would have been the empty spaces.

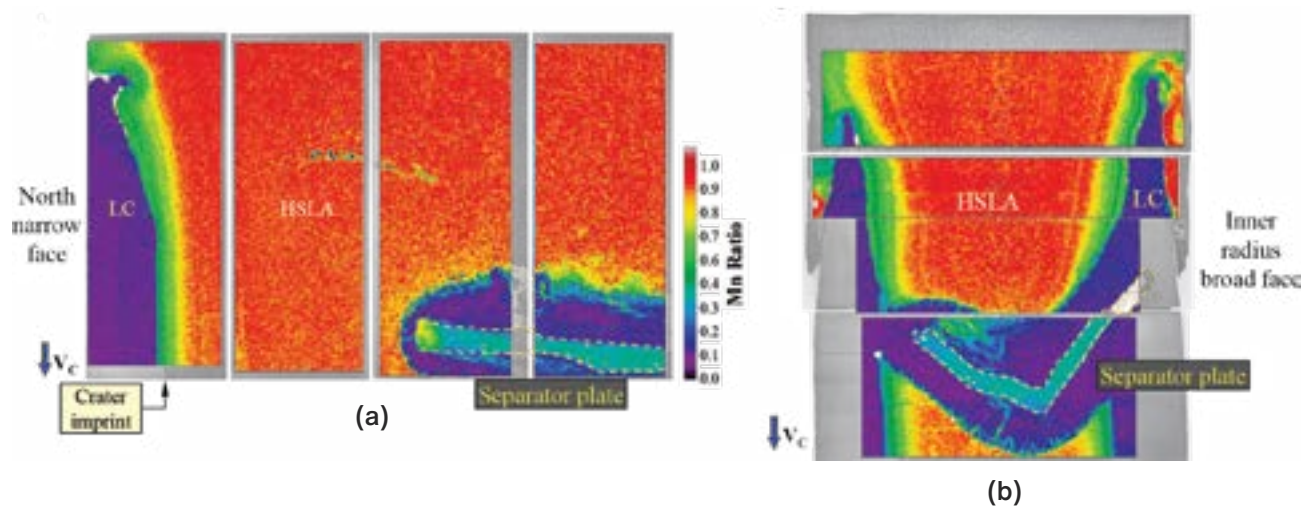
Figure 7

MXRF Mn ratio maps of baseline TC-SP slab samples superimposed onto deep-etched macrostructures from Fig. 4 along broad face cross-section (a) and longitudinal cross-section (b) at mold quarter-width position.

Fig. 7 shows the MXRF Mn ratio area scans of the baseline TC-SP slab samples. Mn ratios of outgoing steel (LC) and incoming steel (HSLA) are distinct, owing to their different Mn specifications. The unique chemical composition of the grade separator plates, as well as the solidification barrier of LC steel around them, are visible. While deep-etching showed a sharp crater wall, the MXRF revealed localized grade mixing and solidification, as shown by the transitional Mn chemistry, distinctive from both the LC and HSLA grades, which also has physical depth, as opposed to a sharp step change.

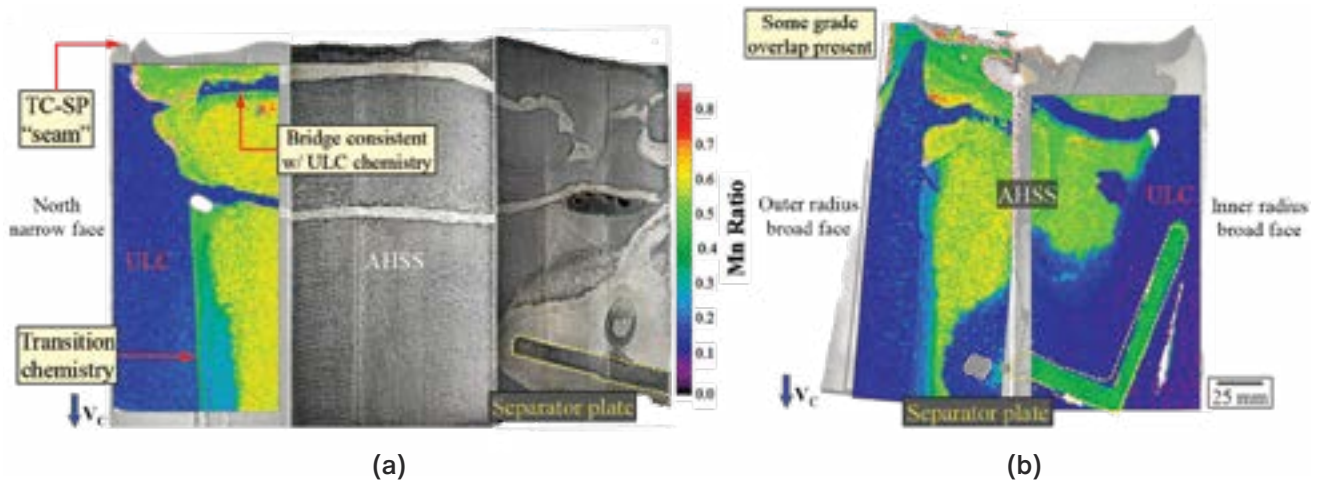
Figure 8

Fig. 8 shows the MXRF Mn ratio area scans of the breakout TC-SP slab samples and provides further insight into the features revealed by deep-etching. The solidification bridges that transverse slab surfaces are consistent with outgoing steel grade (ULC), indicating they had solidified prior to any grade mixing similar to the solidification barrier around the separator plates. The distinctive macrostructure by the crater wall revealed by deep-etching in Fig. 5a has a Mn ratio that is not consistent with either the outgoing or incoming steel grades, further indicating localized grade mixing. This localized grade mixing was further investigated using a different technique discussed in the next section.

MXRF Mn ratio maps of breakout slab samples superimposed onto deep-etched macrostructures from Fig. 5 along broad face cross-section (a) and longitudinal cross-section (b) at mold quarter-width position.

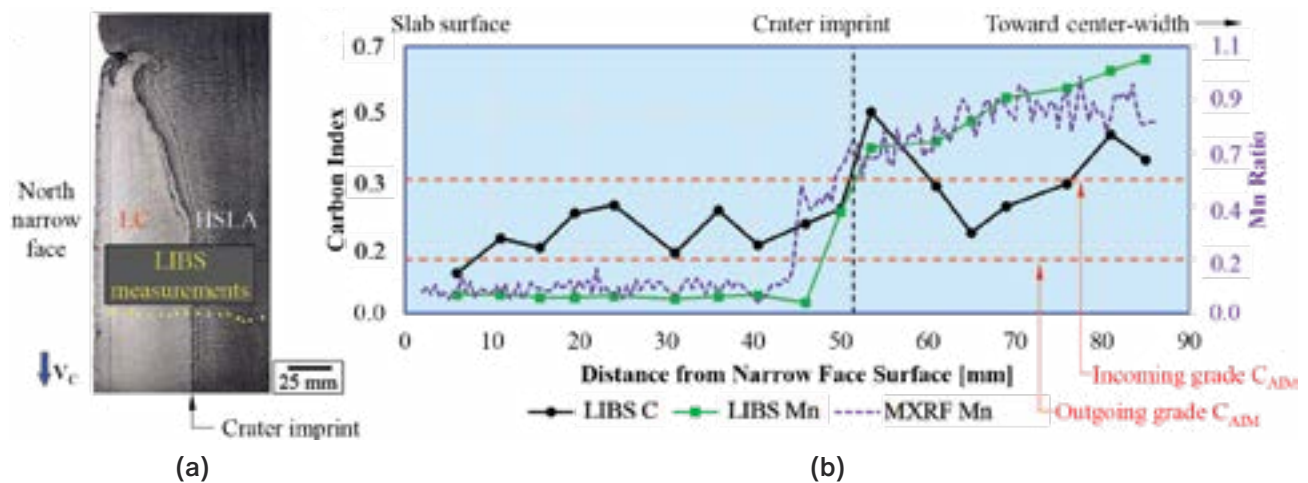
Figure 10

Fig. 10 shows the LIBS C-index and Mn ratio profiles for the baseline TC-SP slab and compares it to the MXRF Mn ratio profile at the same position. Mn ratio measurements between LIBS and MXRF have similar profiles and are reasonably matching. Furthermore, the C-index profile follows the Mn ratio profiles closely. C-index in the LC region closely follows C_{AIM} of the outgoing grade. C-index subsequently increases in the HSLA region within the crater and follows C_{AIM} of the incoming grade. Near the region of the crater imprint, the C and Mn measurements transition in between C_{AIM} of both grades, which is consistent with the localized mixing measured by MXRF.

Baseline TC-SP slab sample with LIBS measurement locations (a); and C-index and Mn ratio profiles obtained by LIBS and MXRF (b).

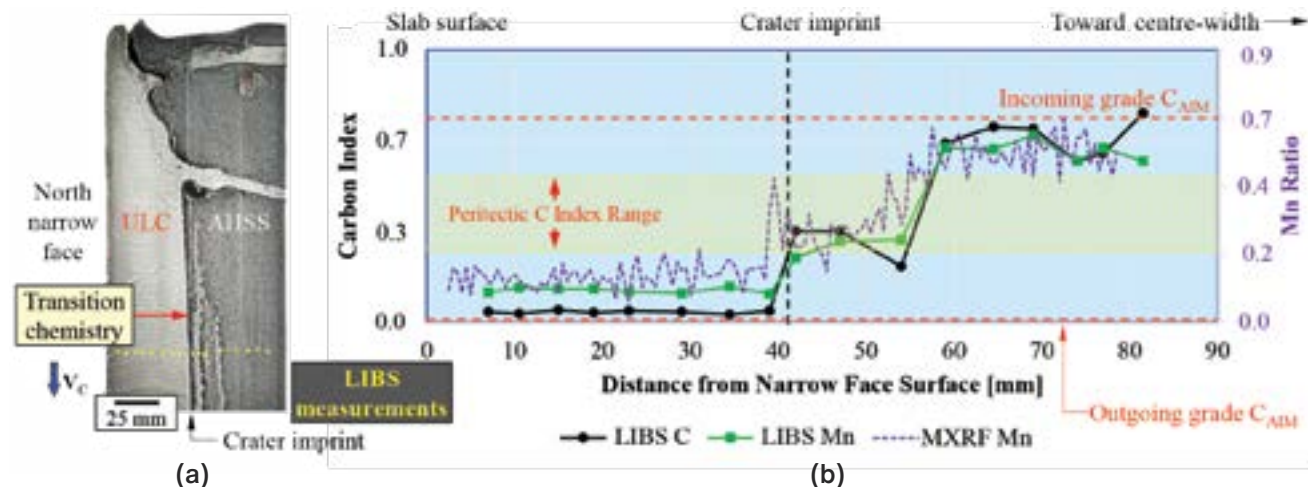
Figure 11

Fig. 11 shows C-index and Mn ratio profiles for the breakout slab. The chemistry profiles exhibit similar behaviors to the baseline case. The distinctive macro-structure near the crater wall, which had a transition Mn ratio by MXRF, also exhibits similar behavior with respect to C-index. In fact, the transition chemistry falls within the peritectic range for C-index.

measurements in the AHSS region are midway between C_{AIM} of the outgoing and incoming grades. Additionally, many of these measurements were within the peritectic range. Continuous casting of peritectic steels have been associated with wavy shell growth in the mold.^{12–14} This phenomenon could also explain the separation of steel or gaps observed along the crater wall near the TC-SP seam in Fig. 11a.

Breakout slab sample with LIBS measurement locations (a); and C-index and Mn ratio profiles obtained by LIBS and MXRF (b).

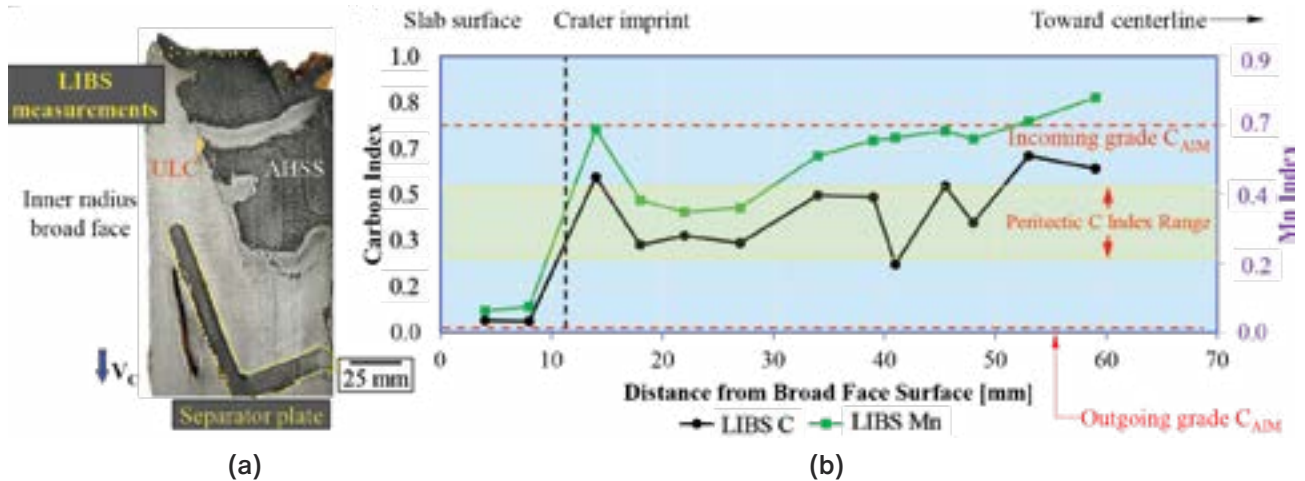
Figure 12

Fig. 12 shows C-index and Mn ratio profiles for the breakout slab near the initiation point. A MXRF scan of that region was not possible owing to the irregular edge. Nonetheless, LIBS Mn ratio has been demonstrated to closely match Mn ratio by MXRF. Many of the C-index

Breakout slab sample with LIBS measurement locations (a); and C-index and Mn ratio profiles obtained by LIBS (b).

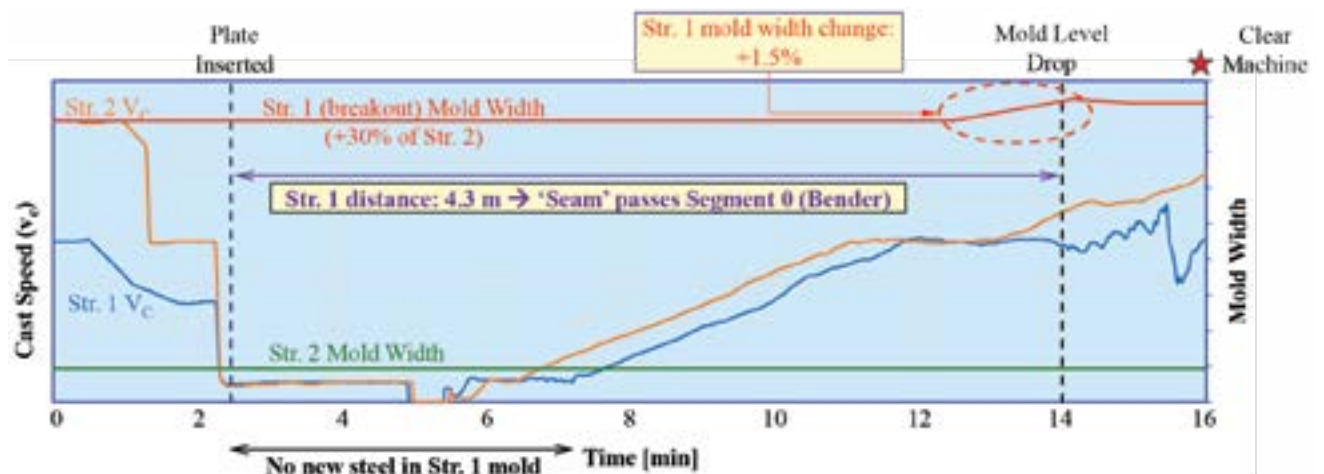
Figure 13

Fig. 13 shows key process data (cast speed [V_C] and mold width) for both strands. As per the TC-SP standard operating procedure,² cast speed is reduced and steel flow into the molds is cut off prior to the FTC. At very low cast speed, tundish is changed and separator plates are inserted into the molds (~2.5 minutes). Flow of liquid steel into the molds is subsequently resumed. It should

be noted it took longer to resume the flow of liquid steel on the Strand 1 mold (breakout strand) compared to Strand 2, which could have resulted in the solidification bridging observed on the slab sample.

Despite this, the TC-SP section of the strand had exited the molds without any issue. However, as that steel segment traveled down the machine, the mold width on Strand 1 had been increased. Based on the distance from the breakout initiation point to the meniscus, the TC-SP section would have been traveling through 1CC's bending segment (Segment 0) during the mold width change. Immediately after the mold width change, the mold level drop was observed indicating the loss of liquid steel containment in the strand, and subsequently the breakout.

Process data of 1CC leading to breakout event.

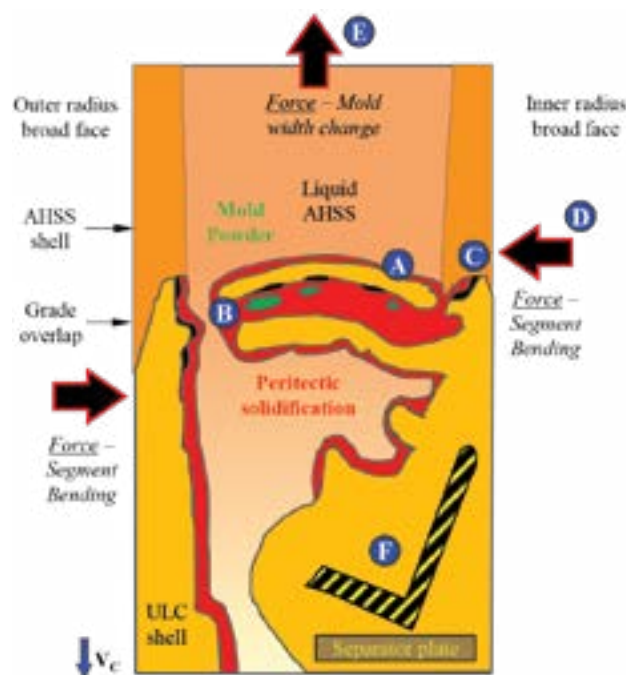
Figure 14

Schematic summary of breakout mechanism.

Based on the evidence provided by deep-etching, MXRF, LIBS and process data review, the contributing factors leading to the breakout event were identified. Fig. 14 shows the schematic summary of the proposed breakout mechanism.

- Integrity of the strand near the grade separator plate position (TC-SP seam) was compromised as a result of the following:
 - The long duration of no incoming steel flowing into the mold (stopper rod closed to stopper rod opened) resulted in heat loss and solidification bridging (A).
 - Solidification bridging inhibited adequate grade mixing within the strand crater.
 - Solidification bridging also resulted in more entrapped mold powder globules (B).
 - Grade mixing between ULC and AHSS grades near the TC-SP seam resulted in localized peritectic solidification near the outgoing grade steel shell and solidification bridges, creating localized regions of shrinkage and gaps between the two grades (C).

- The bending segment exerted force on the weakened TC-SP seam as it traveled through that segment (D).
- A mold width change occurring simultaneous to the TC-SP seam reaching the bending segment exerted additional force on the TC-SP seam (E).
- The grade separator plate insertion was not directly responsible for the breakout event, but rather indirectly by contributing to the longer duration of the TC-SP event (F).

4. Since this incident, ArcelorMittal Dofasco has removed the plate practice and implemented process and scheduling restrictions to prevent reoccurrence, impacting slab yield, but protecting the operators as well as the customer.
