Design of an Active Warning System for Fall Protection

This article is the first in a series of Safety First articles featuring the reports from the recipients of the 2012 Don B. Daily Memorial Fund.

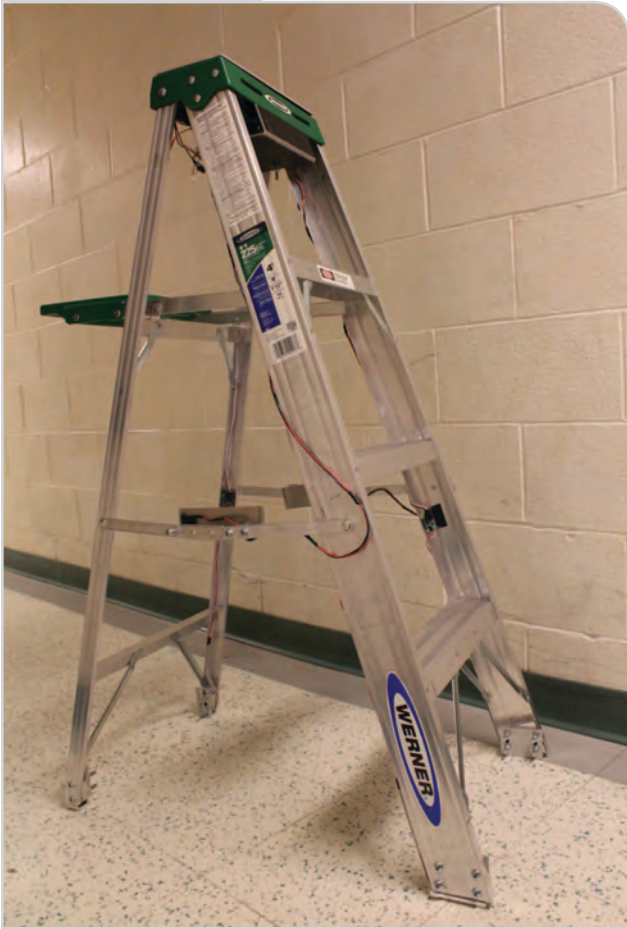
Figure 1

Instrumented step ladder.

Fabrication, system integration and sensor calibration were completed in March 2013. The instrumented ladder is shown in Figures 1–4.

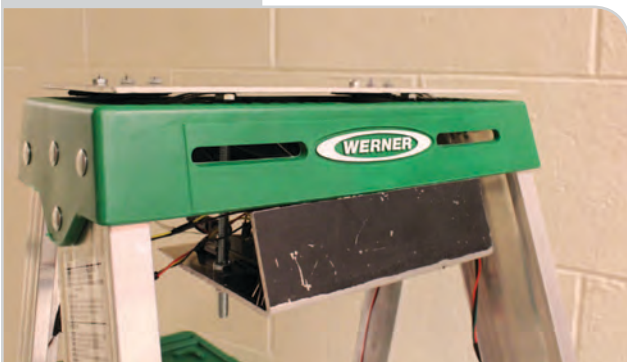
Figure 3

Instrumented top cap detail.

- Switches would be built into the spreader bars, indicating full engagement during setup.
- Force sensors would be integrated into the feet of the ladder; these sensors would be used to detect proper setup (validating that all feet are touching the floor during setup), overload conditions (detecting the total load seen by the ladder) and overreaching by the user (detecting unusual load shifting in the ladder feet).
- Force sensors would be built into the top cap, detecting a user improperly standing on the top cap.

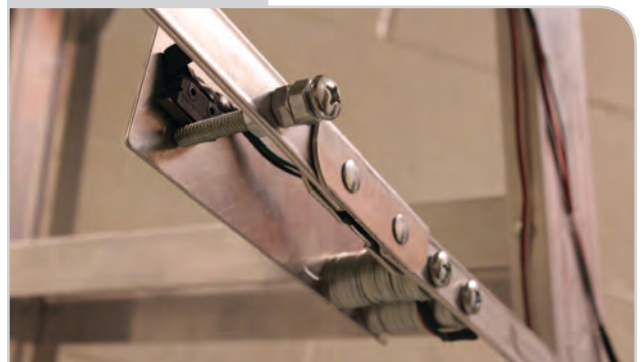
Figure 4

Instrumented spreader bar detail.

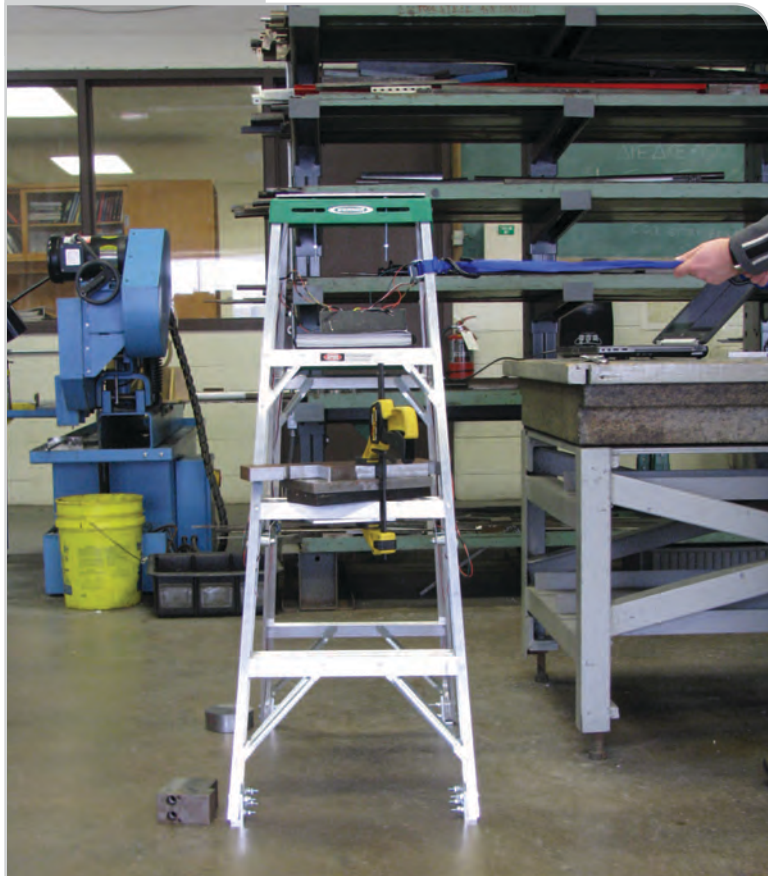
Figure 9

Impending tipover test.

unsafe setup and use conditions. In the test shown in Figure 9, a test load was fixed to the ladder and a strap was used to tilt the ladder, simulating an impending tipover. The corresponding force data at the feet is shown in Figure 10.

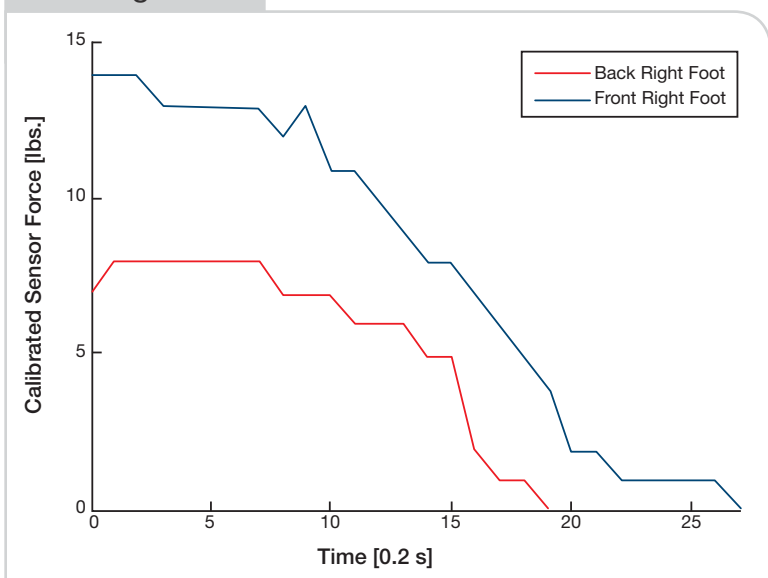
Figure 10

Forces at the feet during impending tipover.
