# Injury on a Construction Site

A construction worker was assigned to guide seven 250 MCM cables into a 6-inch-diameter conduit (Figure 1). In the course of the pull, the overhead pulley assembly became dislodged and injured the worker, hitting him on the head. He was not wearing any personal protective equipment (PPE).

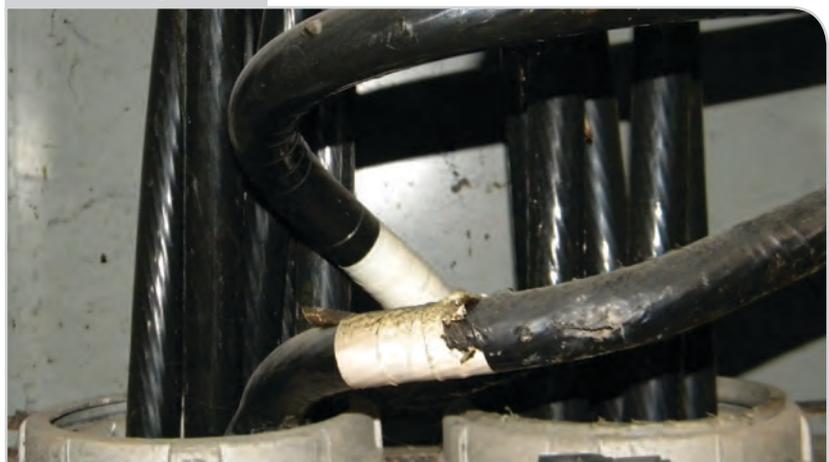
Figure 1

View of cables and conduit.

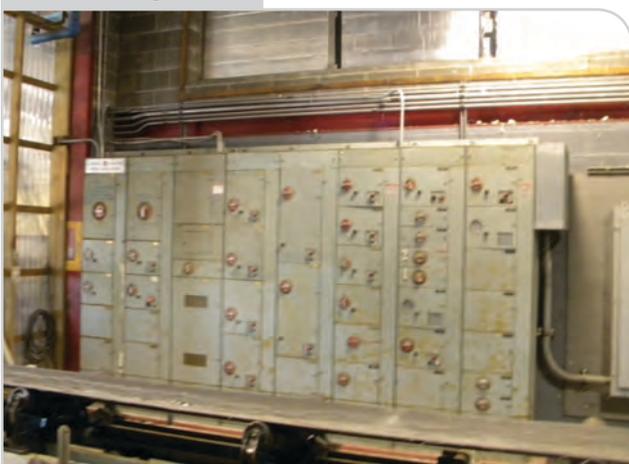
Figure 3

1. The cables each came from a spool set off to the front of a motor control center, were led up to a pulley assembly that was positioned vertically over the motor control center (MCC) and were fed down through the cableway in the MCC (Figures 2–4). From here they entered the conduit at the floor and proceeded about 100 feet down and out horizontally. A tractor was stationed at the ground level and pulled the cables down and into a connection box for splicing.

View of motor control center.

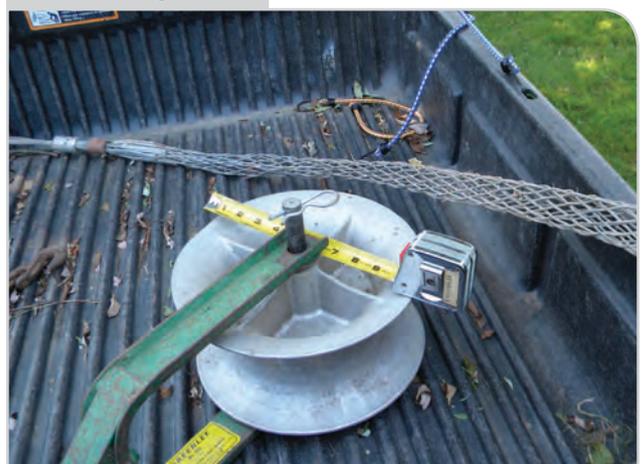
Figure 4

View of pulley and “Chinese finger” in truck bed.
