## Oxygen Safety: The Status Quo May Not Be the Way to Go

### Case Study: Brad's Story

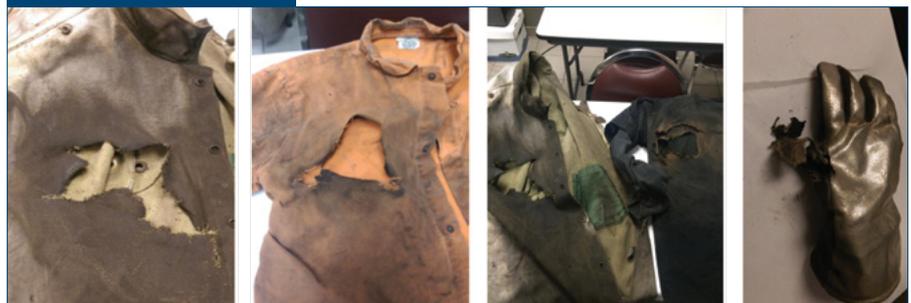
Figure 1

The suspected particle impingement explosion within the carbon steel lance made its way through four layers of clothing: an aluminized coat, a flame-resistant jacket and two 100% cotton shirts (Fig. 1). This doesn't include the burns sustained through his aluminized gloves, hood, neck drape, face shield and

respirator. This resulted in partial-thickness and full-thickness burns to about 25% of his body, requiring extensive skin grafting.

*Damage to personal protective equipment (PPE) as a result of Brad's oxygen lance incident.*

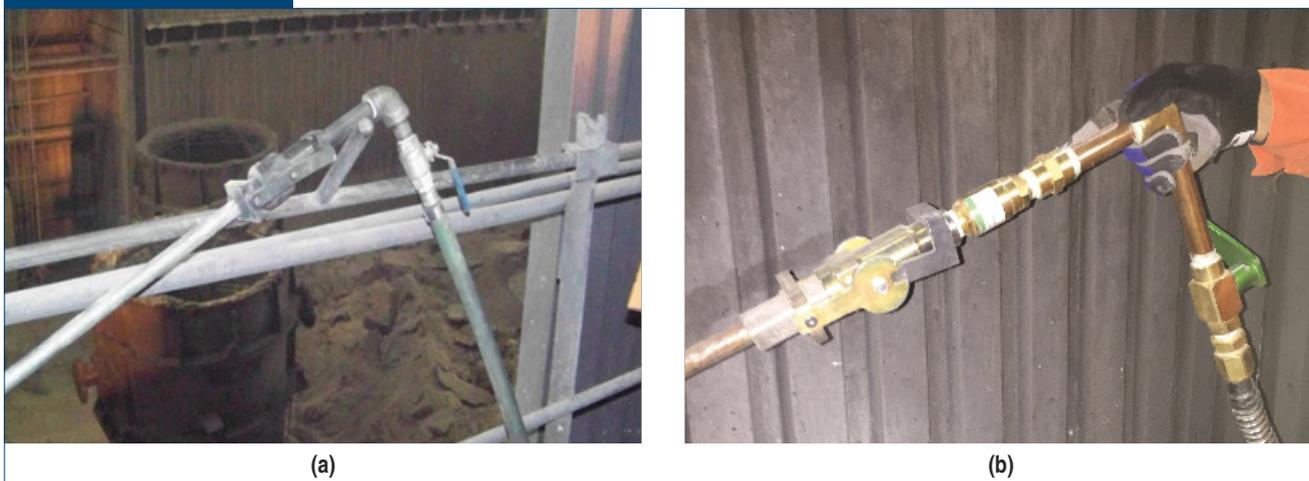
Figure 2

Analysis of the incident led to the determination that there were many contributing factors to Brad's incident, including: equipment being

Pre-incident carbon steel oxygen lance setup (a) and post-incident improved setup (b).

used by employees was not designed for oxygen use; inspections of equipment were found to be insufficient; the job safety analysis (JSA) was inadequate; additional training was needed; and personal protective equipment (PPE) had provided a false sense of security.

The pre-incident carbon steel oxygen lancing setup (Fig. 2a) consisted of a simple hose, simple ball valve, simple hose barb, simple clamp and an “in-house” lance holder. This antiquated setup was replaced with a modern system consisting of CGA fittings, oxygen filter, regulator with pressure gauge, jumper hose and 3,000 psi oxygen swivel, oxygen-rated ball valve, thermal shutoff device, anti-slag safety device, and a lance holder all via a certified third-party supplier specializing in oxygen lancing equipment (Fig. 2b).

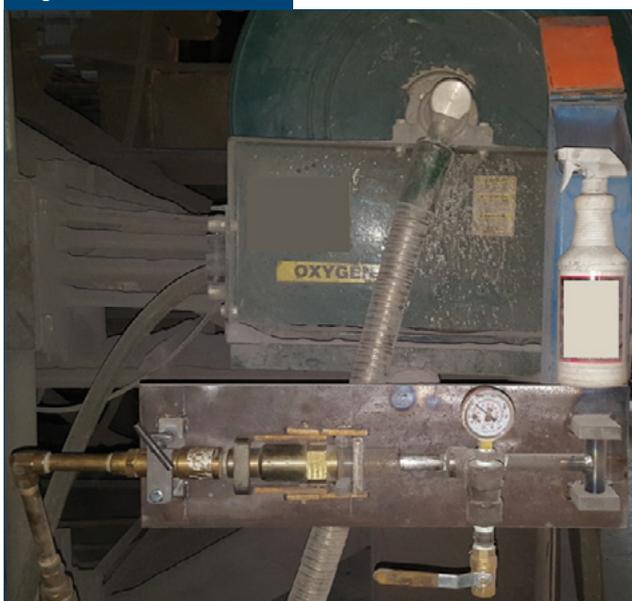
Figure 3

Oxygen lancing system inspection station.

Oxygen lancing system inspection stations were also installed to be used as a testing stand to aid inspections (Fig. 3). The stands are designed to securely hold the system in place while the oxygen lance rod holder is pressurized. Once the lance rod holder is pressurized, the pressure gauge is monitored and oxygen leak detector fluid is applied to detect leaks.
