NDT Magnetic Techniques Applied to Degradation Measurement on Rolling Mill Rolls

Keywords: rolling mill, Magnetic Barkhausen Noise, Eddy Current Testing

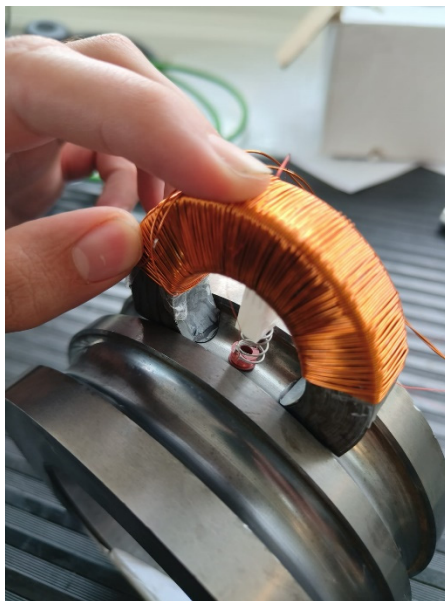
For MBN inspection we will use a modified shape yoke for the rolling side of the samples (Fig. 7).

Figure 7. Modified yoke and U shape yoke

Since we have to adapt to the shape of the roll groove to examine the rolling side, the contact of the probe is not complete due to the complex geometry, making the signal weaker in general for this prototype on the rolling side. For the analysis of the

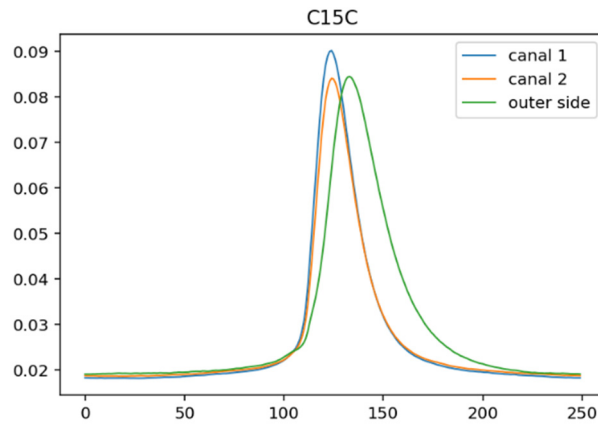
Figure 10: MBN profile comparison between outer part and external part

We can see how the signal obtained in the 3 cases is very similar. These results are consistent with the fact that this roll appears to be practically new, so that it would not have suffered deformations in its internal structure yet due to the steel rolling process.

Now we will make an average of each of the grooves and compare the signal with the one obtained from the measurement of the external part (Fig. 10).

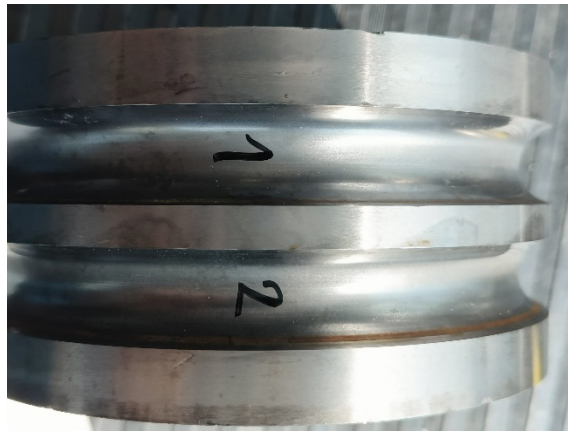
In the figures we can see how the direction in which the curves move is very similar in all the samples, in addition to the fact that there are no large variations in the modulus of the curves (Fig. 16), as was the case with the MBN technique.

Max module
C15C canal 1	1286,35
C15C canal 2	1288,35
C15C external	2031,35
C20C canal 1	1451,53
C20C canal 2	1389,80
C20C external	1981,43
YGR45 canal 1	1304,34
YGR45 canal 2	1330,00
YGR45 external	1847,53

Figure 16 Max. module of each inspection by eddy current
