Steeled for Safety: Visual Aid Technologies to Increase Safety With Material Handling

Christopher Machut
Netarus LLC, Norfolk, Va., USA
chris@netarus.com

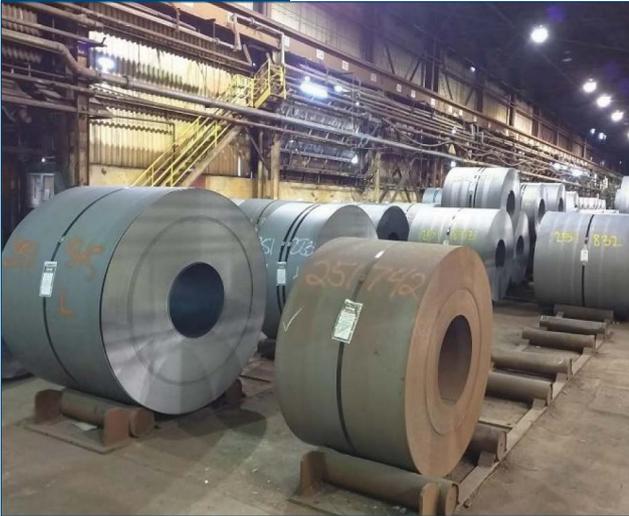
Figure 1

Cold-rolled coils in a warehouse.
