Report on the NSSMC Oita Works' Fire Accident in its Plate Mill - The cause and preventive measures -

May 18, 2017

Nippon Steel & Sumitomo Metal Corporation

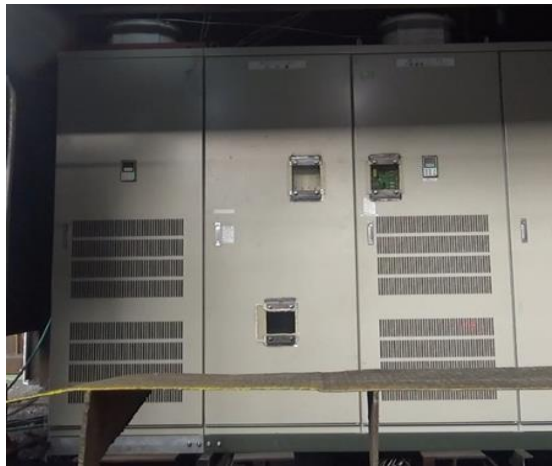
- Reproduction Experiment

We reproduced the circumstances, which did result in the occurrence of arcs from the contactor and the ignition of flammable components of the panel (acrylic board, etc.)

The experiment using a mock panel
