# Reduction of Surface Defects on Steel Pieces That Occur in the Early Stages of Casting

While scabs and longitudinal surface cracks of rolled products can occur during the rolling process, there are cases where surface cracks on billets do not disappear during the rolling process and remain. This article introduces efforts against the following surface cracks that appear during the continuous casting process, which occur at the initial casting stage at the bottom of oscillation valleys: (1) Short-stroke/high-cycle mold oscillation; (2) Optimization of mold dimple patterns; and (3) Improving responsiveness of mold level control.

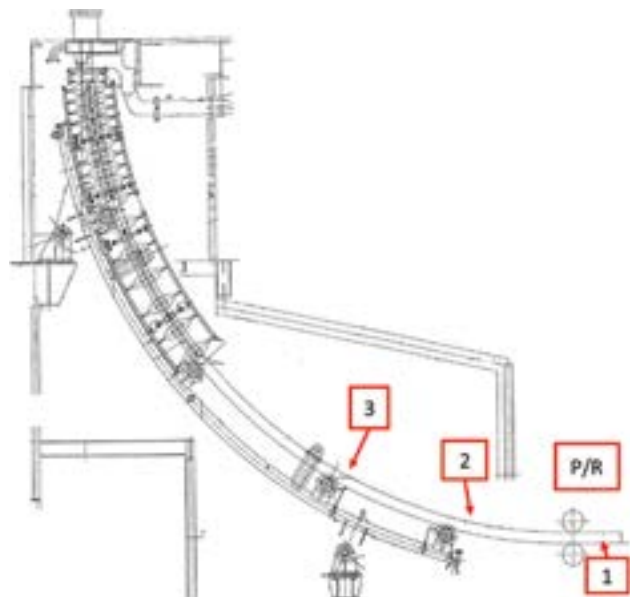
Figure 5

Points where samples were taken on the continuous casting line.

through the pinch rolls. The spray flowrate and cooling position in the secondary cooling zone of the billet were adjusted, but the occurrence rate of peeling defects in deformed steel bars did not decrease. In order to confirm the occurrence location of transverse corner cracks, the billet was stopped during casting in the spray cooling zone before passing through the pinch rolls and samples were taken at the positions shown in Fig. 5. As a result, it was found that the cause of the transverse corner cracks had already occurred before the billet was straightened by the pinch rolls.

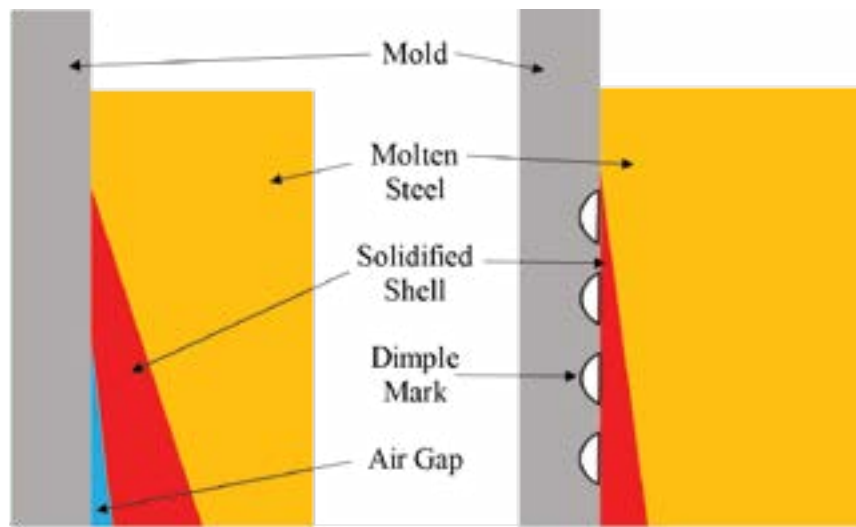
Figure 10

When the dimple processing position was moved closer to the meniscus, the cooling suppression effect was greater and the transferred dimple marks were clearer. The dimple mold had four rows of dimples, one with seven dimples from the top and one with six dimples from the bottom. When there was a dimple mark on the surface of the billet, it was always a seven-dimple mark. In order to confirm the effect of dimple marks on transverse cracks at the corners of billet, a mold test was conducted with different dimple processing.

Dimple mold effect image.

From this, it was speculated that when the very thin solidified shell passes through the top stage of dimples, dimple marks are generated on the billet surface due to thermal expansion, and that these get caught on the dimples during withdrawal, causing cracks in the billet corners along the oscillation marks.

As a result, with a mold that did not have dimple marks, peeling defects were significantly reduced, but diamond-shaped deformation of the billet and associated internal cracks occurred. With a mold in which the top stage of dimple processing was lowered, it was possible to suppress the occurrence of peeling defects while also suppressing deformation of the billet.
