Investigation on Caster Breakout During Flying Tundish Change and Separator Plate Using Innovative Techniques at ArcelorMittal Dofasco's No. 1 Continuous Caster

A caster breakout event occurred at ArcelorMittal Dofasco's No. 1 Continuous Caster in proximity to a grade transition with a flying tundish change and separator plate. Practices of flying tundish changes and separator plates have been well-established to cast grades of different chemistries with minimal interruption to productivity. Hence, it was unusual that a breakout occurred, well below the mold, despite these practices and this specific grade transition being successful multiple times prior. This article discusses innovative tools and techniques for the extensive investigation carried out and proposes an explanation of the breakout event, supported through evidence in the autopsy.

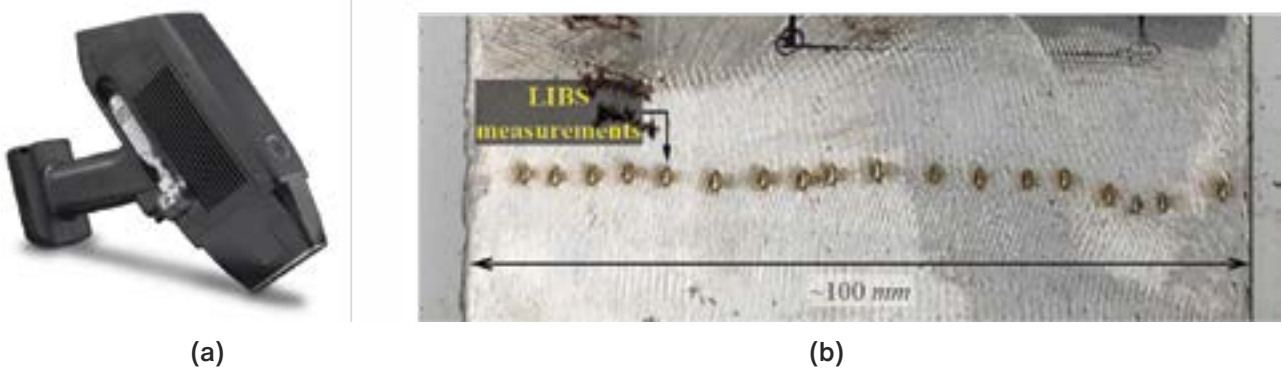
Figure 9

Laser-induced breakdown spectroscopy (LIBS) analyzer (a); and LIBS “burn” marks for spot chemistry measurement (b).

The MXRF device generates high-resolution area maps of Mn composition (among other elements), but it cannot detect or measure carbon. However, LIBS is capable of detecting both carbon and manganese, but can only provide spot measurements. For this investigation, a LIBS gun measured multiple spots along the slab samples' cross-sections (Fig. 9). This article will report LIBS Mn measurements as Mn ratio — similar to the MXRF device, and carbon measurements as C-index — a normalized and unitless metric comparable to carbon wt. %. The Mn ratio profile generated by LIBS was also compared to the results generated by MXRF.
