## Electric Arc Furnace Explosions: A Deadly but Preventable Problem

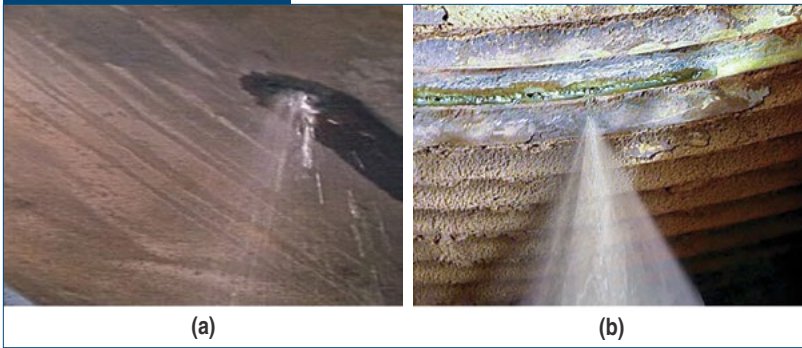
Figure 2

Leak in a non-pressurized spray cooling system (a) vs. leak in a pressurized tubular system (b) (5 gallons/hour vs. 16,000 gallons/hour).

leaves the spray system it is at atmospheric pressure, as compared to typically 60 psi for pressurized tubular equipment. The significance is that, in the event of a crack or leak, spray cooling will not force high volumes of water into the furnace as a pressurized tubular system does. For a comparable cooling supply flowrate, tubular equipment will introduce more than 3,000 times more water into a furnace than a spray cooling system.

For example, a 2-square-inch hole in a tubular panel operating at 60 psi will force approximately 16,000 gallons per hour into the furnace. By comparison, the same 2-square-inch hole in the spray cooling practice will introduce less than 5 gallons into the furnace in the same hour. In minimizing the chance of excess water entering the furnace, non-pressurized spray cooling addresses the root cause of EAF accidents in a proactive and preventive manner (Fig. 2).

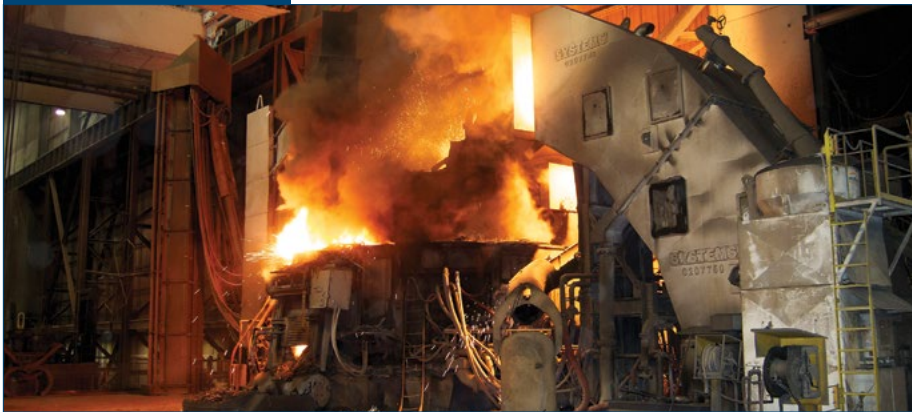
Figure 4

Spray-cooled furnace and duct.
