Treading Around the Dangers of Off-the-Road Mobile Equipment Tires

Author

Carl Daniel
safety manager, Edw. C. Levy Co.,
Columbus, Miss., USA
cdaniel@edwlevy.net

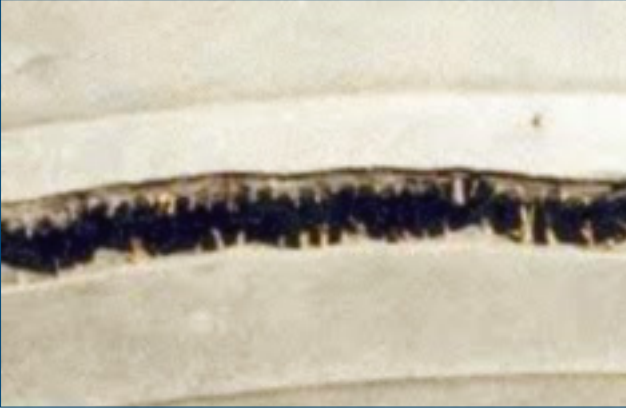
Figure 1

Detailed photo of a zipper rupture.

Another factor that can be a contributor to tire failure is underinflation and overloading. OSHA standard 1910.177 Servicing Multi-Piece and Single-Piece Rims defines a tire as being flat when the tire has been “driven underinflated at 80% or less of its recommended pressure”¹ which, for example, would be 80 psi for a 100 psi tire. Running mobile equipment with underinflated tires can lead to degradation of the tire, which can cause a zipper rupture (Fig. 1). A zipper rupture is a circumferential rupture in the mid-sidewall of a steel-belted tire. These ruptures are unpredictable and can occur without any warning.

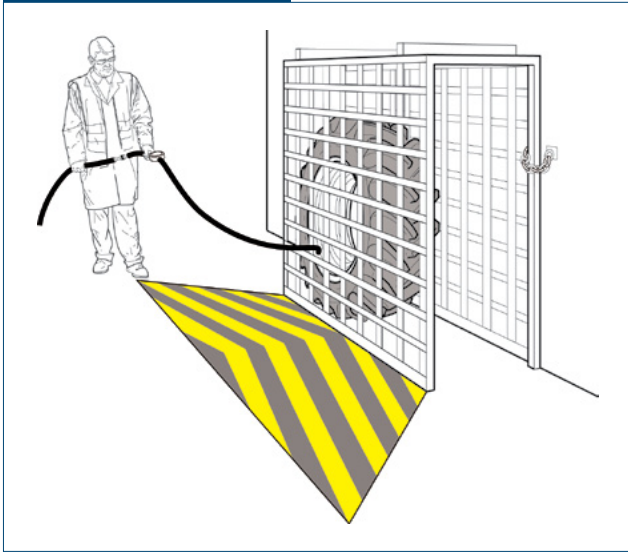
Figure 3

Tire inflation practices.

Tire inflation also poses many risks for employees working with tires. Tires that are underinflated should be removed from the equipment to be safely serviced. The tire should be placed into an OSHA-approved tire safety cage, when possible, and a remote airing device used. A clip-on chuck should be used and there should be a sufficient length of hose between the clip-on chuck and the in-line valve (if one is used) to allow the employee to stand outside the trajectory (see Fig. 3).
